# Somerset County Council

### Section 19 Investigation Report

<b>Date of Incident:</b>	20 <sup>th</sup> October 2021	<b>Date of Report: 11th November 2022</b> <b>Version: 34.1</b> <b>Status:</b> adding feedback from park homes group
<b>Site / Catchment Location:</b>	Ilminster

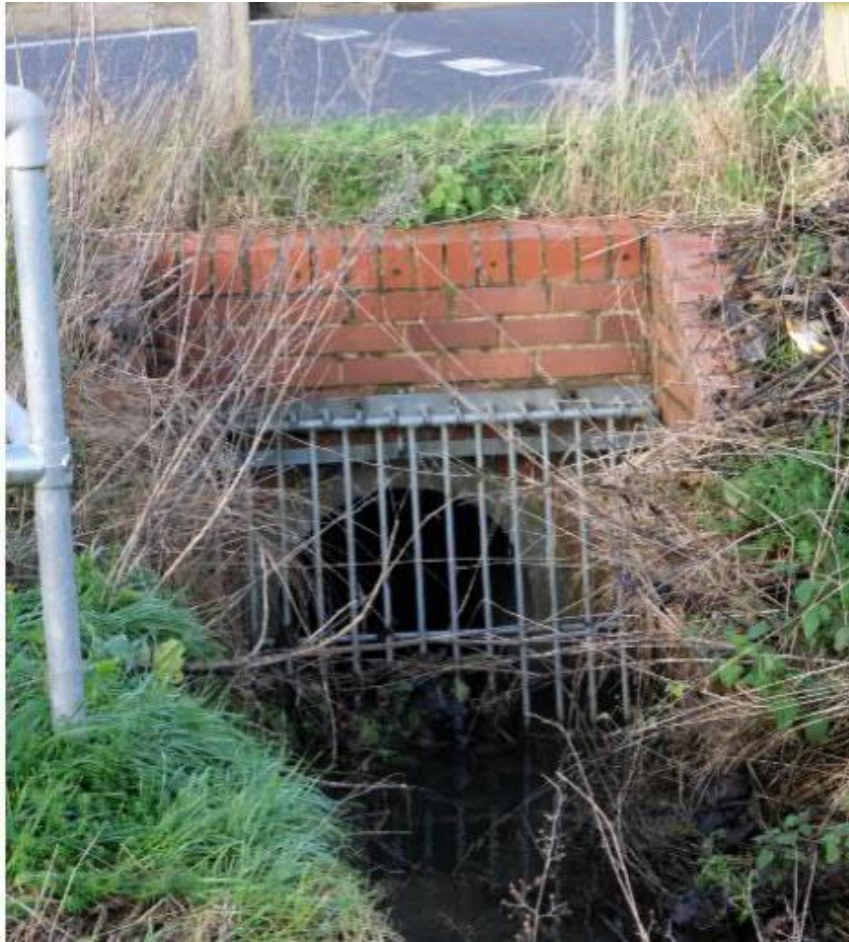
According to the reports of agencies out on the night, the flooding at Ditton Street was believed to be due to a combination of urban surface water, surface water coming off of land at the end of Shudrick Lane and the top of Listers Hill, and water spilling from the Shudrick Stream. Drains were reported by residents as being blocked. There have also been reports that ditches have not been cleared by land owners. The Shudrick stream runs along Shudrick Lane, and at one point enters a culvert, which feeds into a large drain running under the Tesco petrol station, and emerges in Abbots Close. The culvert appears to have been overwhelmed by the volume of water coming down the Shudrick Stream. If it had been blocked, we would expect to see more debris attached to the grate in front of the culvert in the photograph below. The overwhelming effect was supported by the testimony of a local resident, who said that he had never seen so much water coming down the Shudrick catchment into the culvert by Tesco, and that it appeared to overwhelm the stream and culvert, which then compounded the subsequent surface water flooding on Ditton Street. The culvert, at 600mm diameter, is quite small for the size of catchment.

***Figure 11: Culvert in Shudrick Lane, taken some time after the incident.***

This stretch of the Shudrick Stream, including the culverted reach in question, is Main River and as such the EA is the flood risk management authority for this stretch. Under their permissive powers, they undertake periodic inspections of the culvert and channel. If there are significant concerns, and if they are able to, they exercise their powers to mitigate the situation. Ultimately the responsibility falls to the riparian owner. The EA's last culvert survey was undertaken in February 2017. This survey found no problems in the majority of the culvert from the inlet on down, but in the lower section (where it becomes an old masonry arch structure), there are two service pipes passing across the culvert, which pose a potential blockage risk. The pipes would be very difficult to remove, and at least one is currently in use for conveying sewage.

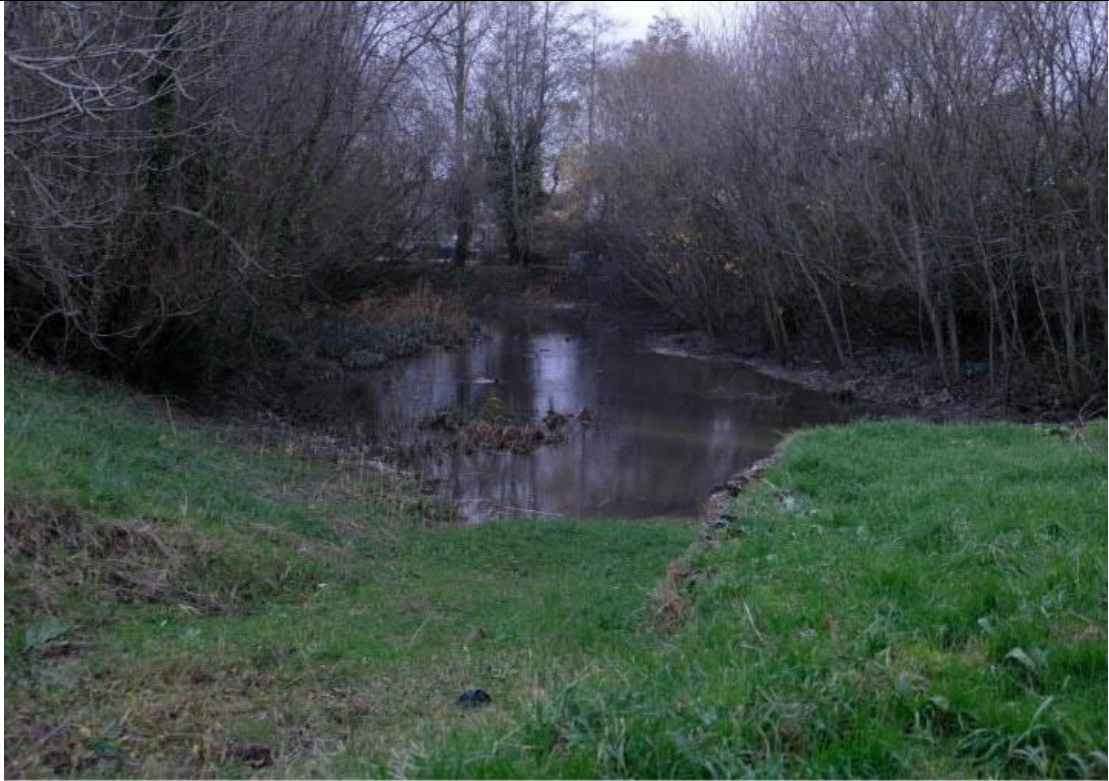
***Figure 12: Storage area near Station Road. (Taken after flood waters had subsided)***

Within the culvert, the Shudrick Stream then flows to the west under Ditton Street and Wharf Lane. Further downstream on the Shudrick the watercourse passes through a housing development in an open channel before flowing into a storage feature upstream of Station Road (as seen in Figure 12).

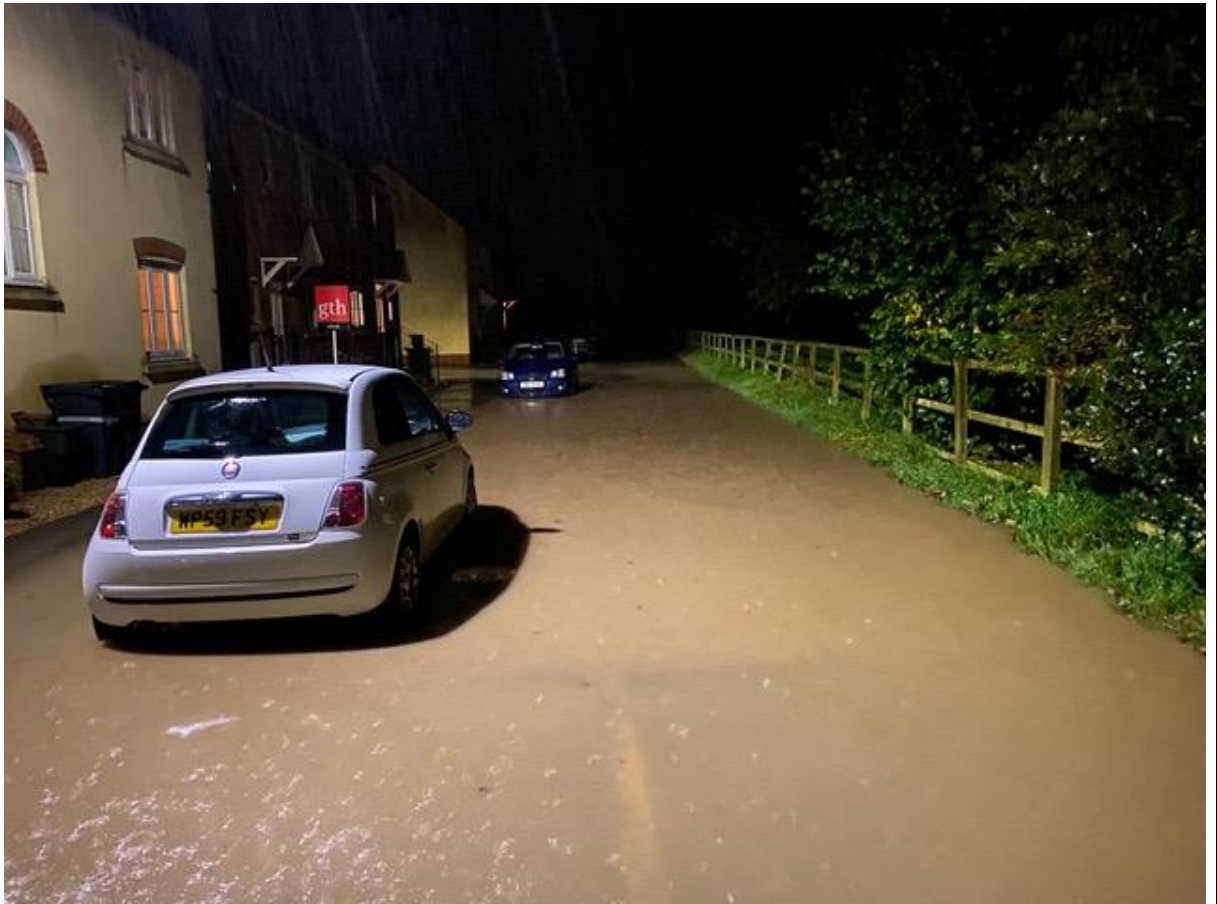
***Figure 13: East end of Shudrick Lane at Walnut Close.***

This photograph was taken close to where the road ends and the fields begin; the surface water floods down the road and into Ditton Street (which is half a metre lower than the top of the town culvert in Shudrick Lane) where it floods homes and shop premises. This roadway leads into fields where the area is in Flood Zone 2-3. On the right, on the other side of the wooden fence, is the Shudrick Stream.

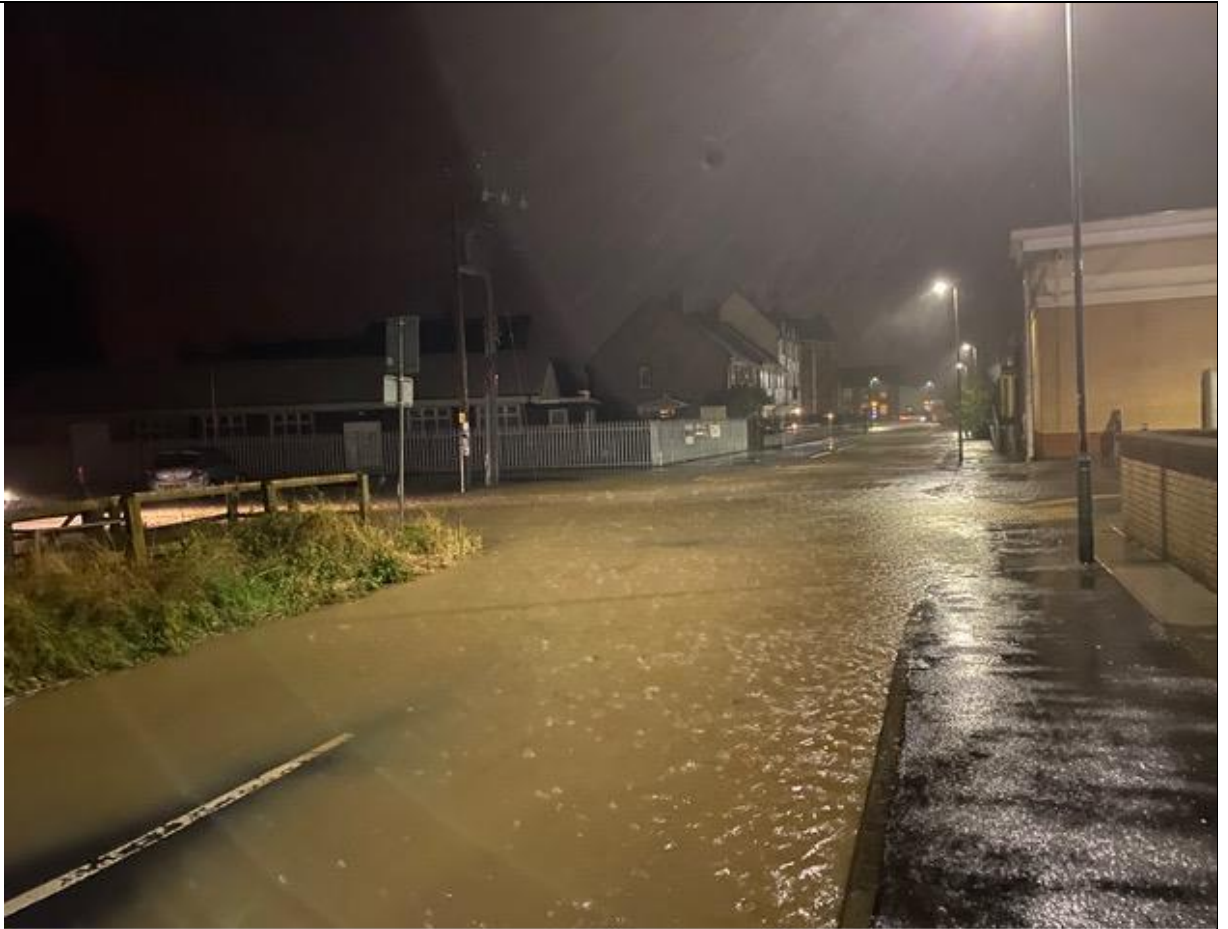
***Figure 14: Looking west down Shudrick Lane.***

Tesco car park is on the right, just outside of the photograph, and there is a small car park on left. Further to the left is the Swanmead school playing field, part of which also flooded. The entrance to the small car park, where the wooden fence ends, is the start of the town culvert on the Shudrick Stream.

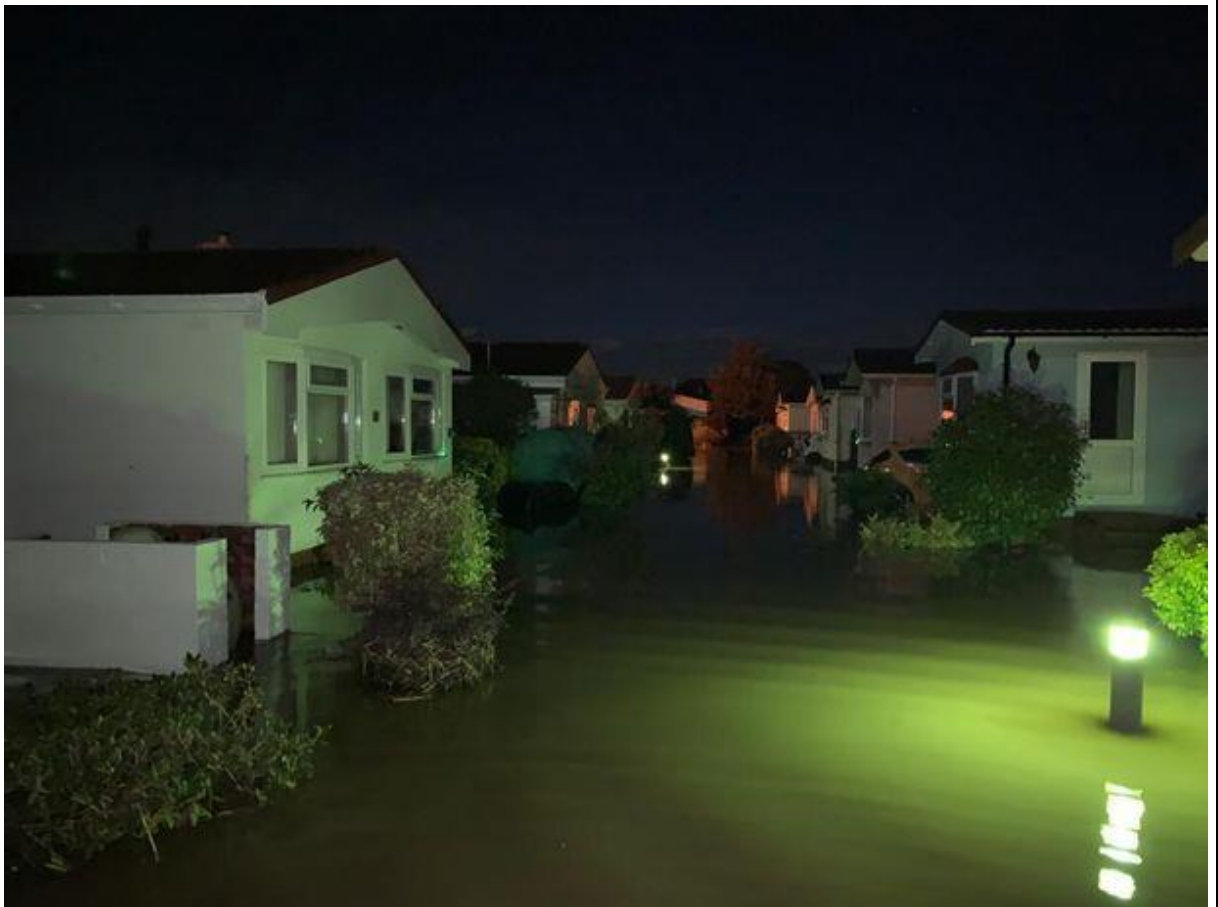
*Figure 15: Holway House Park*

**Holway House Park** was one of the worst affected areas with depths of water being described as up to 1.25 meters. Around 19 of the park homes were flooded internally, with nine being damaged beyond repair. A further 13 properties along Green Lane flooded with depths to around a metre. Thanks to its elevated ground level, none of the park homes in Home Farm Park were flooded internally, although there was external damage to garages and vehicles. There were an additional three commercial properties flooded in the Rose Mills Industrial Estate, which is on the left bank of the Isle upstream of Hort Bridge. From the damage witnessed in the buildings it was evident that there were water depths of up to 10 centimetres.

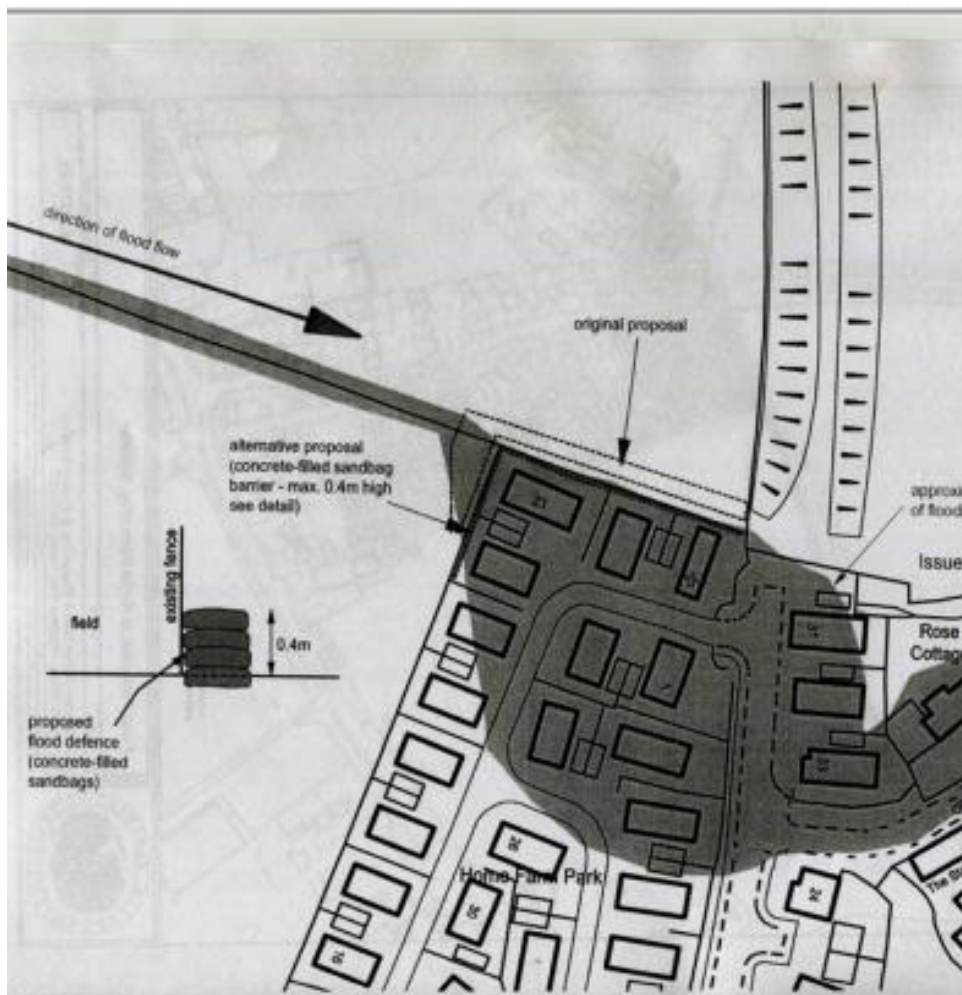
**Figure 20: Proposed bunds at the back of Home Farm Park.**

A resident has reported that "When viewed in person from the field to the North of the Park homes it's clear to see how the Park home gardens have increased slightly in size over many years flattening the Bund, filling the adjoining ditch and removing any usefulness of the original built bund.". There have been other reports that the bund has degraded, in various ways and for various reasons. Not knowing the original design parameters, it is difficult to say how much degradation has taken place. It may be better, rather than try and restore the bund to an unknown original condition, to ascertain what design parameter we wish to use and rebuild to that standard.

Further work needs to be done to understand the parties responsible for ownership and improvement of the bund around the Park Homes. The condition of the bund needs to be examined and improved or repaired as required.

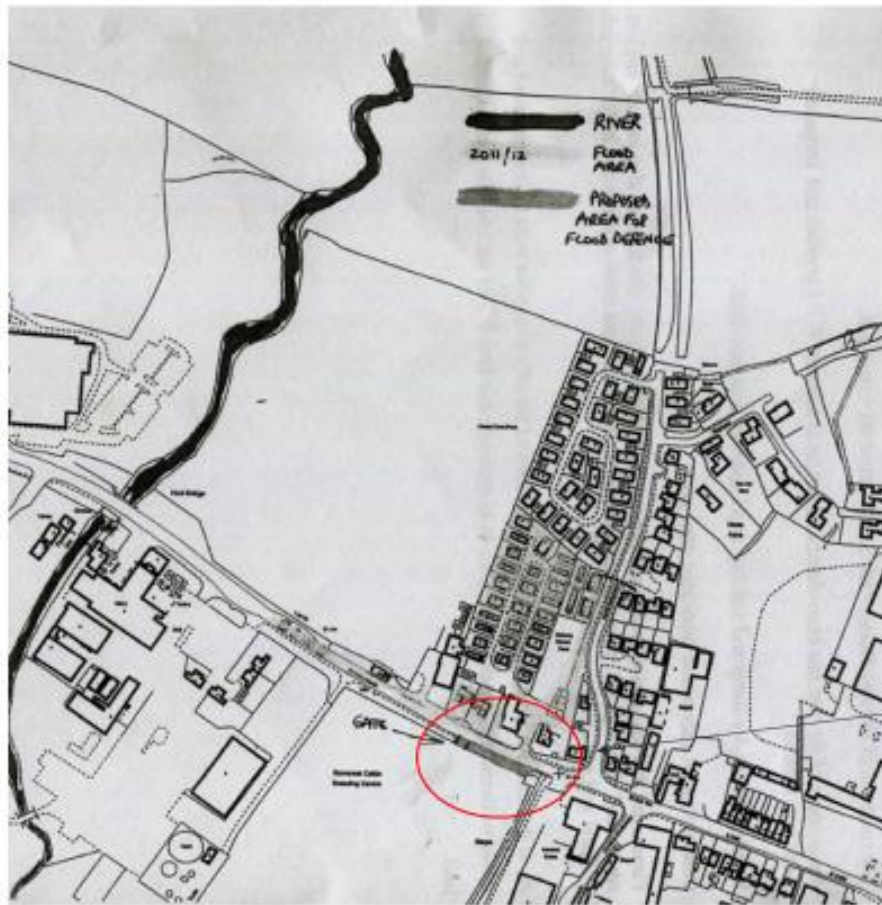
**Figure 22: Proposed cattle grid and ditch on Station Road.**

Further works were proposed to install a cattle grid structure next to the drainage ditch on Station Road, designed to divert water coming across the field away from the main Station Road surface, and down the ditch that runs alongside the old station area.

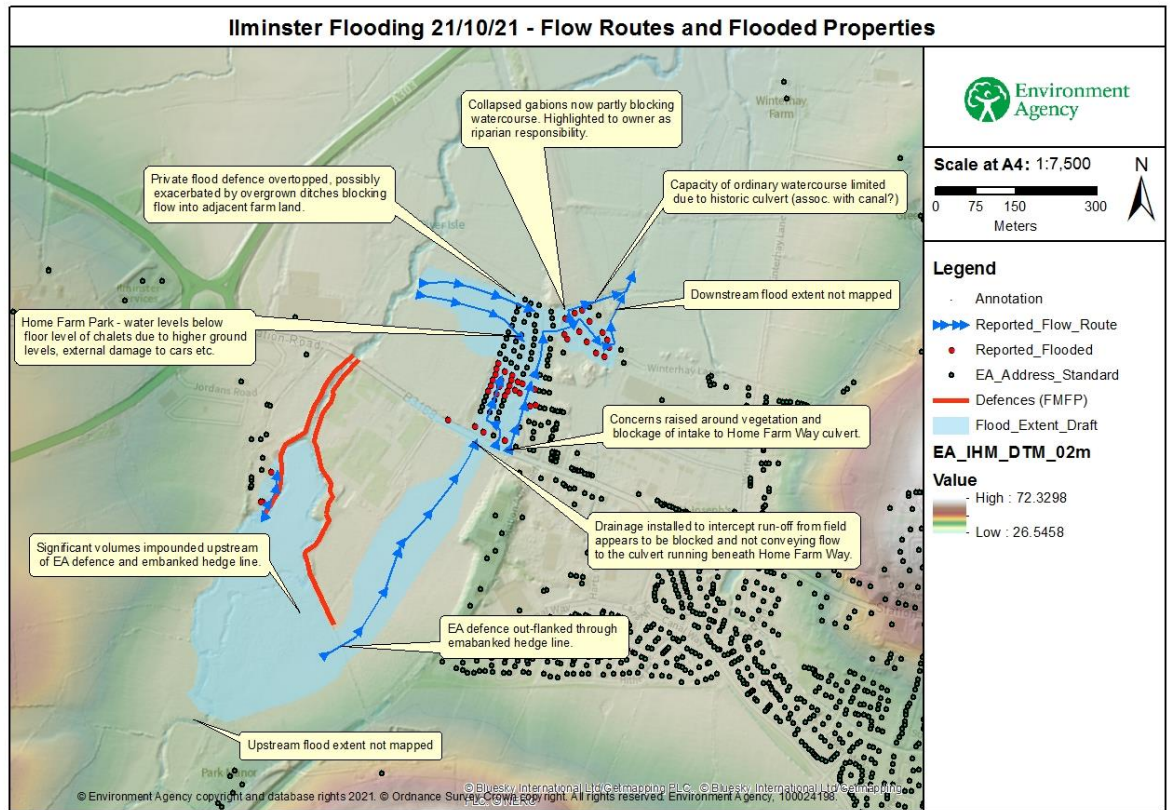
**Figure 27: Flow paths at the west end of Ilminster. Source: Environment Agency, November 2021.**

The information in this map represents an outline estimate of the flood mechanisms and flooded properties during the flood of 20/21 October 2021 on the west side of Ilminster. It is based on information gathered in the aftermath of the flood and may not be a complete and accurate summary, but is based on the best data and resource available at the time.

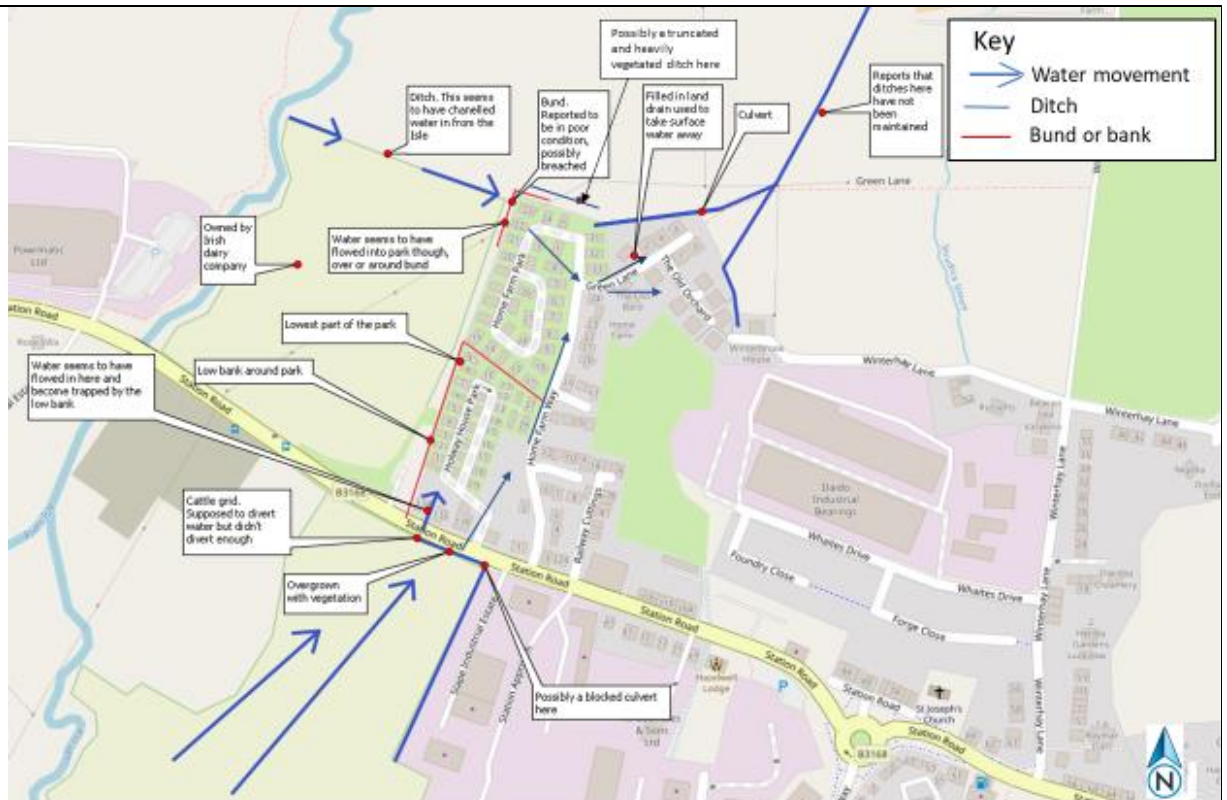
**Figure 28: Further detail of west Ilminster**

Most of the volume of water seems to have come from the river Isle. The river spilled over its banks both to the north of the Hort bridge, and around the flood defences to the south of the bridge. Water from the northern spill flowed up a ditch to the edge of Home Farm Park. From here it flowed through, around and/or over the bund into Home Farm Park, and across into Green Lane. Water coming up from the south combined with pluvial flow across the fields, flowed into and over the cattle grid, and across Station Road into Holway House Park and the houses next to it. This water was trapped in situ by the low bank around the park. Another portion of the water that came up from the south flowed across Station Road and across into Home Farm Way. This flowed down Home Farm Way to join up with the water from the north in Green Lane and the Old Orchard.

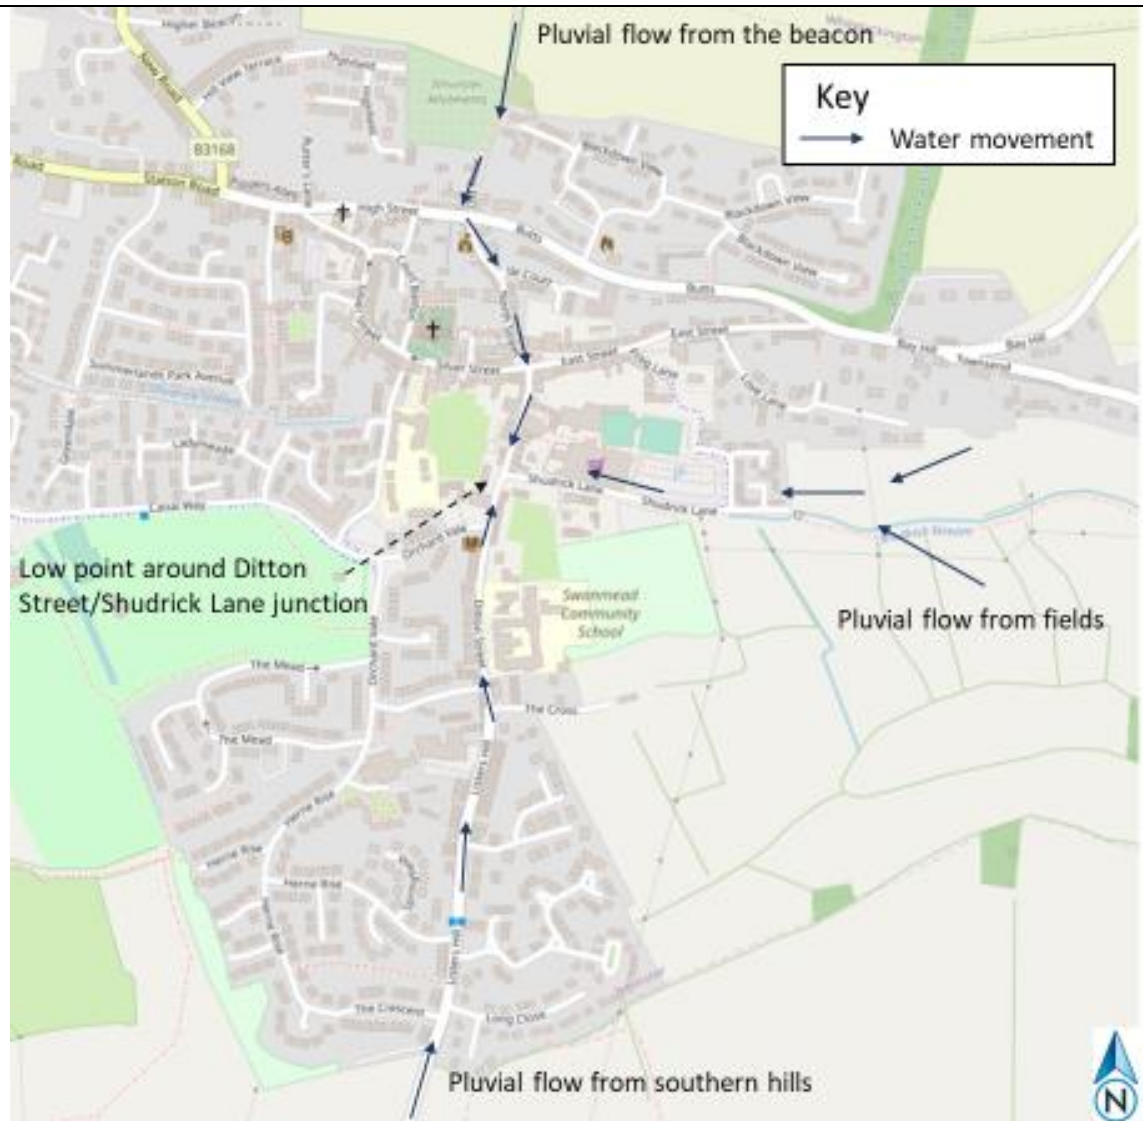
EA, local residents and Councillors observed these flow paths, and also that the pluvial flow comes off fields, carrying soil, stones, and debris with it. This will tend to collect in and possibly block drains during an event. Long term local residents also observed the massive amount of water coming from these sources, and said that they felt even free running drains would not have coped with all of it.

**Figure 29: Pluvial flows around east Ilminster**

Residents have raised the issue of the crops being grown around the periphery of Ilminster and the surrounding villages. Maize has recently started to be grown, and this particular crop is associated with high levels of runoff. This could be exacerbating the surface water and pluvial flow element of the flooding experienced.

The Ilminster Town Council should liaise with FWAG and local landowners to discuss the issue of maize growing in the area, ascertain if it is a problem, and see if more benign crops or growing methods can be found.
