Somerset County Council

Section 19 Investigation Report

Date of Incident:	20 th October 2021	Date of Report: 22nd September 2022 Version: 3.8 Status: all amendments received to date added – EA and Darren Duffield. Inc new return period.
Site / Catchment Location:	Ilminster

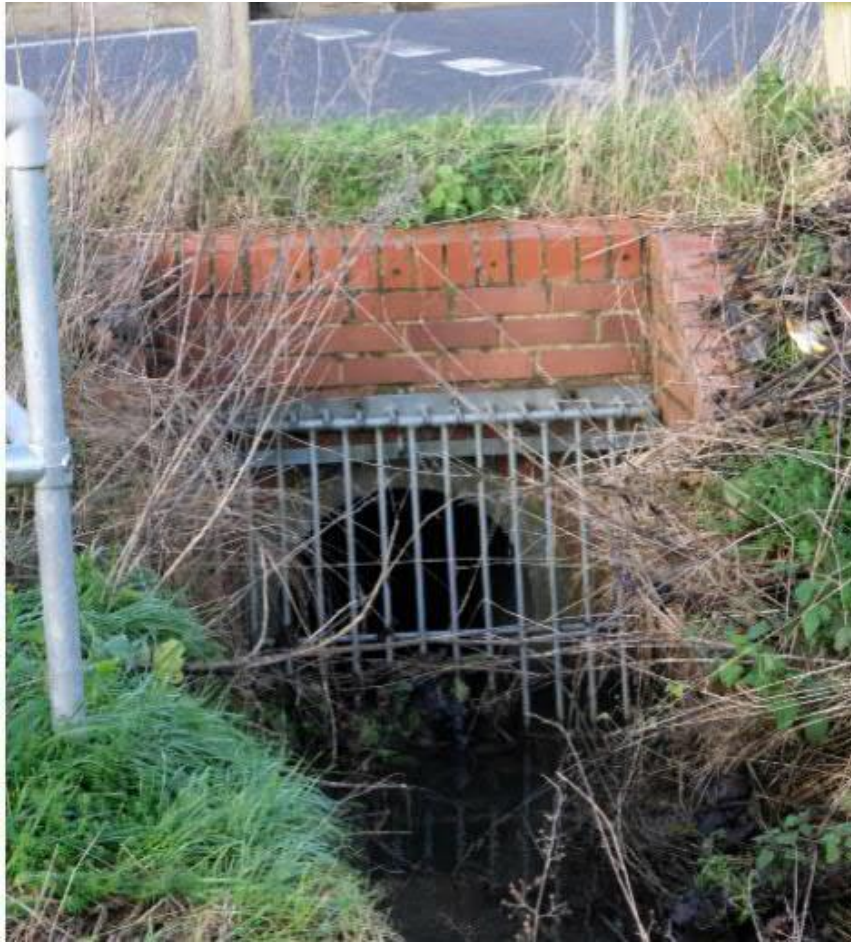
According to the reports of agencies out on the night, the flooding at Ditton Street was believed to be due to a combination of urban surface water, surface water coming off of land at the end of Shudrick Lane and the top of Listers Hill, and water spilling from the Shudrick Stream. Drains were reported by residents as being blocked. There have also been reports that ditches have not been cleared by land owners. The Shudrick stream runs along Shudrick Lane, and at one point enters a culvert, which feeds into a large drain running under the Tesco petrol station, and emerges in Abbots Close. The culvert appears to have been overwhelmed by the volume of water coming down the Shudrick Stream. If it had been blocked, we would expect to see more debris attached to the grate in front of the culvert in the photograph below. The overwhelming effect was supported by the testimony of a local resident, who said that he had never seen so much water coming down the Shudrick catchment into the culvert by Tesco, and that it appeared to overwhelm the stream and culvert, which then compounded the subsequent surface water flooding on Ditton Street. The culvert, at 600mm diameter, is quite small for the size of catchment.

Figure 11: Culvert in Shudrick Lane, taken some time after the incident.

This stretch of the Shudrick Stream, including the culverted reach in question, is Main River and as such the EA is the flood risk management authority for this stretch. Under their permissive powers, they undertake periodic inspections of the culvert and channel. If there are significant concerns, and if they are able to, they exercise their powers to mitigate the situation. Ultimately the responsibility falls to the riparian owner. The EA's last culvert survey was undertaken in February 2017. This survey found no problems in the majority of the culvert from the inlet on down, but in the lower section (where it becomes an old masonry arch structure), there are two service pipes passing across the culvert, which pose a potential blockage risk. The pipes would be very difficult to remove, and at least one is currently in use for conveying sewage.

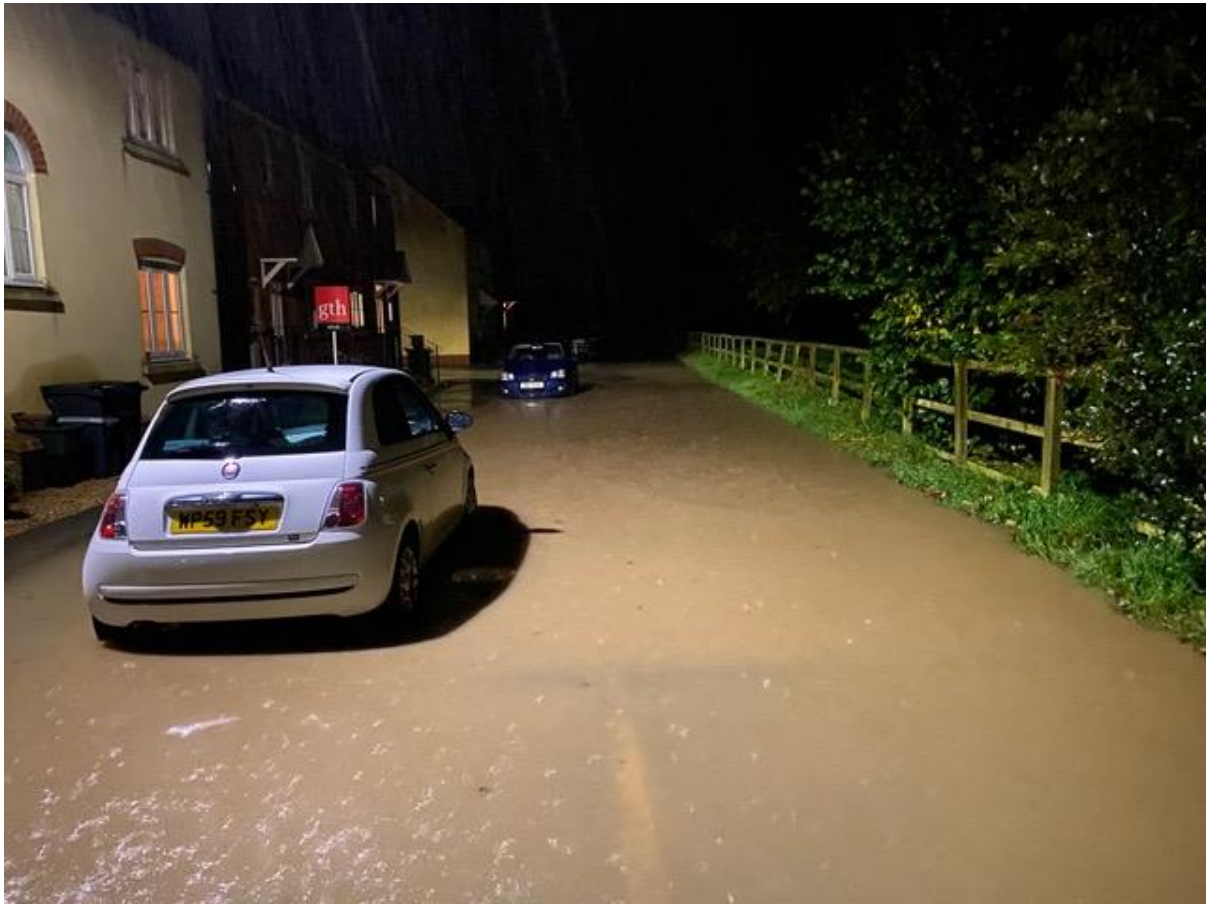
Figure 13: East end of Shudrick Lane at Walnut Close.

This photograph was taken close to where the road ends and the fields begin; the surface water floods down the road and into Ditton Street (which is half a metre lower than the top of the town culvert in Shudrick Lane) where it floods homes and shop premises. This roadway leads into fields where the area is in Flood Zone 2-3. On the right, on the other side of the wooden fence, is the Shudrick Stream.

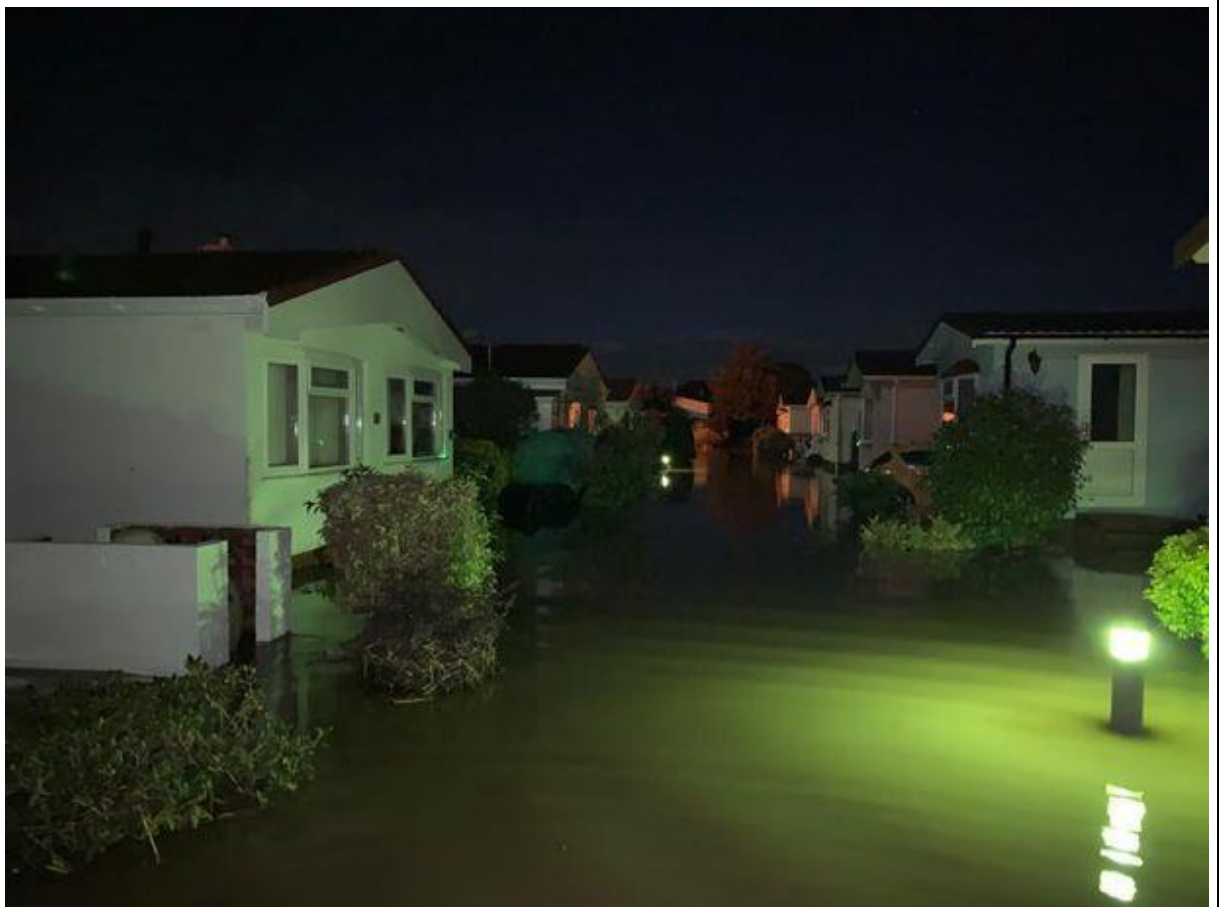
Figure 15: Holway House Park

Holway House Park was one of the worst affected areas with depths of water being described as up to 1.25 meters. Around 19 of the park homes were flooded internally, with nine being damaged beyond repair. A further 13 properties along Green Lane flooded with depths to around a metre. Thanks to its elevated ground level, none of the park homes in Home Farm Park were flooded internally, although there was external damage to garages and vehicles. There were an additional three commercial properties flooded in the Rose Mills Industrial Estate, which is on the left bank of the Isle upstream of Hort Bridge. From the damage witnessed in the buildings it was evident that there were water depths of up to 10 centimetres.

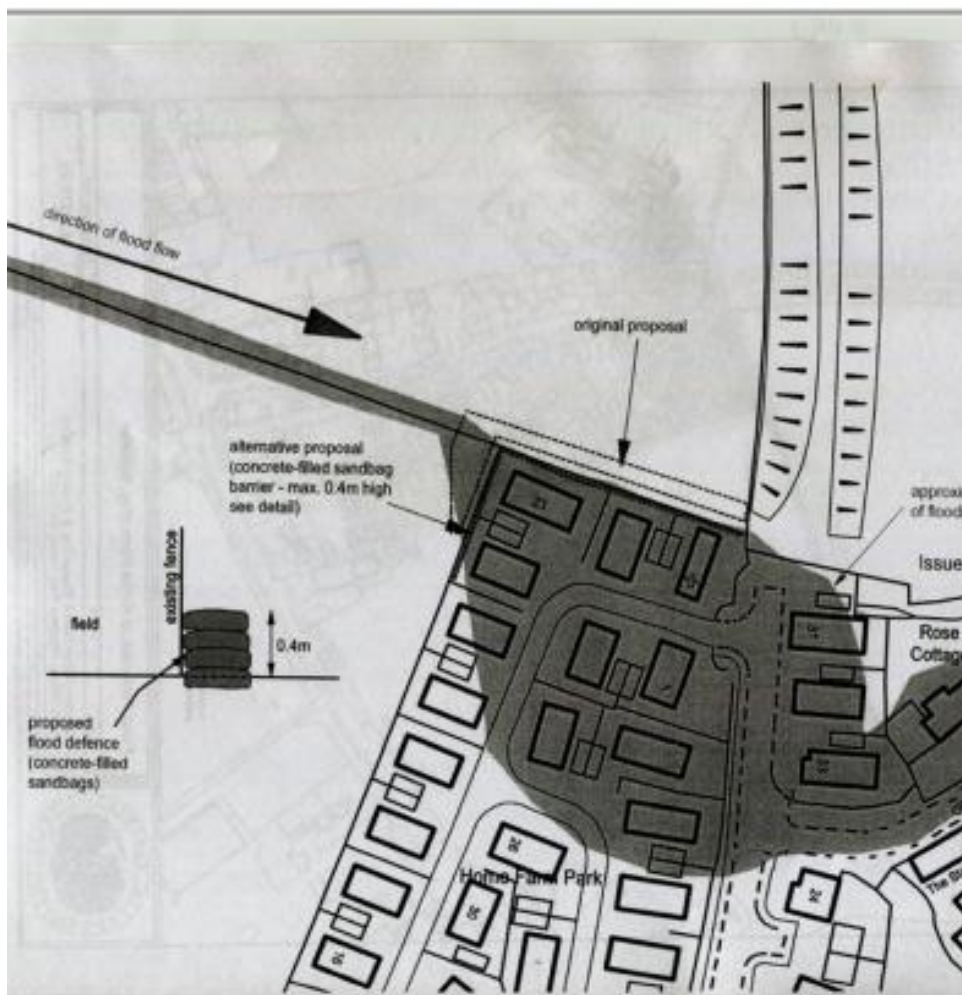
Figure 20: Proposed bunds at the back of Home Farm Park.

The deep grey area shows the area flooded in 2008.

SCC records show that the funds were granted to Ilminster Town Council as requested. However, there are other records which suggest (but don't state explicitly) that this funding was used only to build the cattle grid and drainage system on the south of Station Road, and that the bund was provided by another method. In short, ownership of this bund is still not certain, although the EA are certain that they were not involved. The bund, ditch and cattle grid are visible on site. Furthermore, the bund is visible on Lidar data¹, and the cattle grid has been referred to during residents' testimony of the October 2021 event. Details of the construction of the cattle grid were included with the application, but unfortunately not of the bund. It is also not known what the design parameters of the bund were;

A resident has reported that “When viewed in person from the field to the North of the Park homes it’s clear to see how the Park home gardens have increased slightly in size over many years flattening the Bund, filling the adjoining ditch and removing any usefulness of the original built bund.”. This should be looked at in concert with further work on the ownership and condition of the bund.

Further work needs to be done on the ownership of, and responsibility for, the bund around the Park Homes. The condition of the bund needs to be examined and improved or repaired as required.
