# Flood Investigation Report

*Section 19 Flood and Water  
Management Act 2010*

**Ilminster**

<b>Date of Incident:</b>	20 <sup>th</sup> October 2021	<b>Date of Report: 27<sup>th</sup> January 2023</b> <b>Version: 5.0</b> <b>Status: Final</b>
<b>Site / Catchment Location:</b>	Ilminster

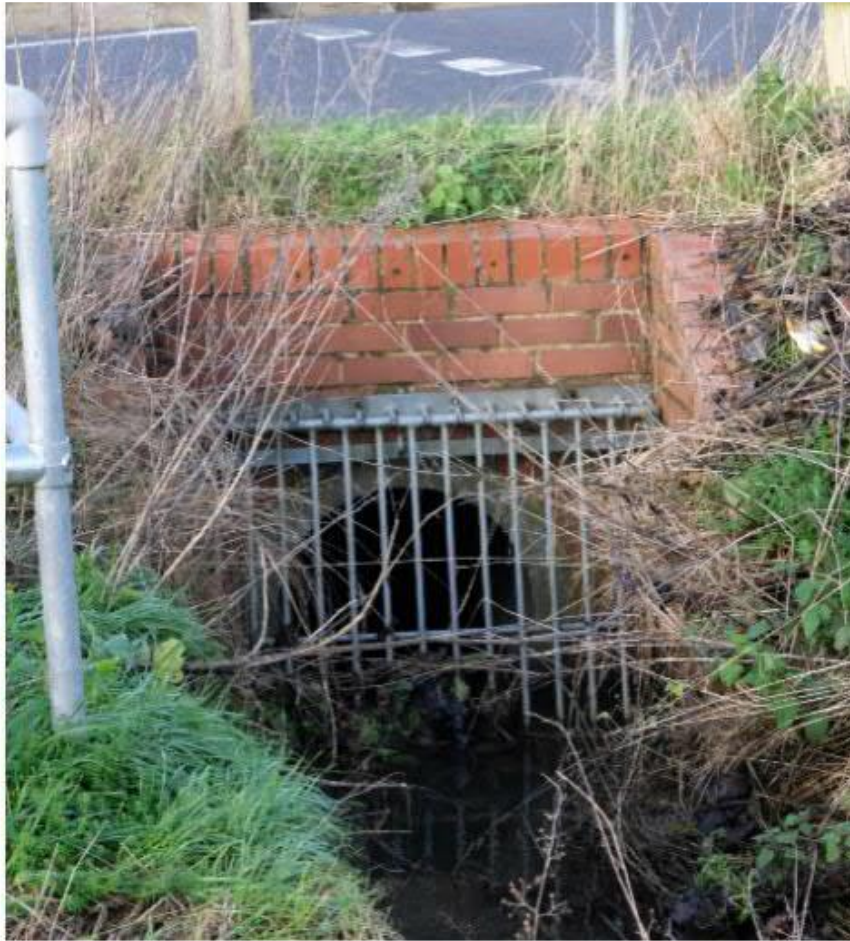
***Figure 11: Culvert in Shudrick Lane, taken some time after the incident.***

According to the reports of agencies out on the night, the flooding at Ditton Street was believed to be due to a combination of urban surface water, surface water coming off of land at the end of Shudrick Lane and the top of Listers Hill, and water spilling from the Shudrick Stream. Drains were reported by residents as being blocked. There have also been reports that ditches have not been cleared by land owners. The Shudrick stream runs along Shudrick Lane, and at one point enters a culvert, which feeds into a large drain running under the Tesco petrol station, and emerges in Abbots Close. The culvert appears to have been overwhelmed by the volume of water coming down the Shudrick Stream. If it had been blocked, we would expect to see more debris attached to the grate in front of the culvert in the photograph below. The overwhelming effect was supported by the testimony of a local resident, who said that he had never seen so much water coming down the Shudrick catchment into the culvert by Tesco, and that it appeared to overwhelm the stream and culvert, which then compounded the subsequent surface water flooding on Ditton Street. The culvert, at 600mm diameter, is comparatively undersized for a catchment from which it collects.

This stretch of the Shudrick Stream, including the culverted reach in question, is Main River and as such the EA is the flood risk management authority for this stretch. Under their permissive powers, they undertake periodic inspections of the culvert and channel. If there are significant concerns, and if they are able to, they exercise their powers to mitigate the situation. Ultimately the responsibility falls to the riparian owner. The EA's last culvert survey was undertaken in February 2017. This survey found no problems in the majority of the culvert from the inlet on down, but in the lower section (where it becomes an old masonry arch structure), there are two service pipes passing across the culvert, which pose a potential blockage risk. The pipes would be very difficult to remove, and at least one is currently in use for conveying sewage.

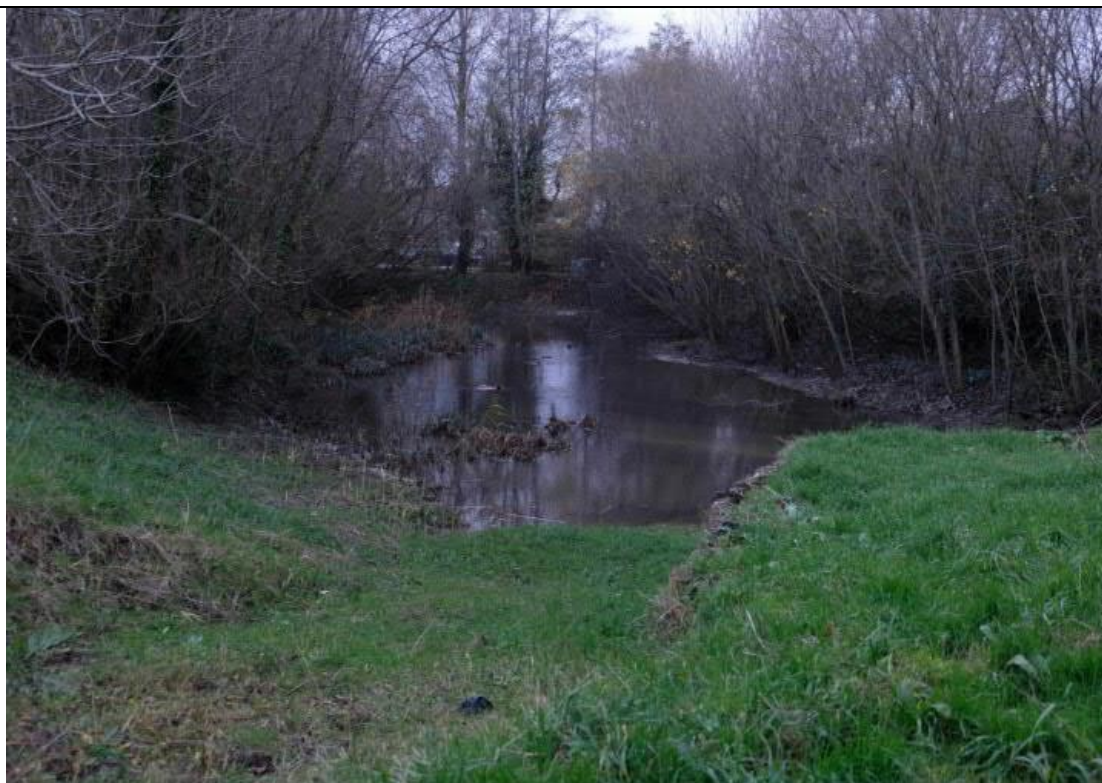
***Figure 12: Storage area near Station Road. (Taken after flood waters had subsided)***

Within the culvert, the Shudrick Stream then flows to the west under Ditton Street and Wharf Lane. Further downstream on the Shudrick the watercourse passes through a housing development in an open channel before flowing into a storage feature upstream of Station Road (as seen in Figure 12).

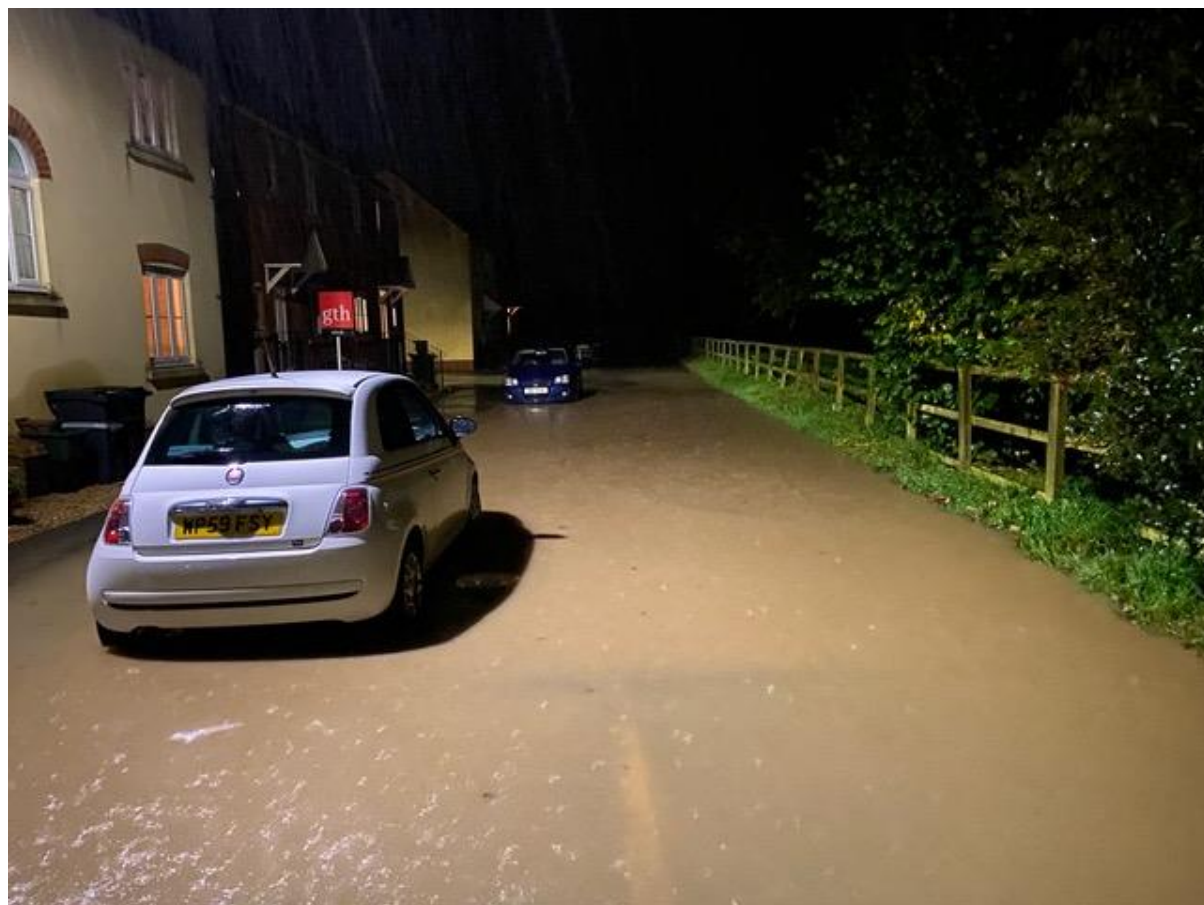
***Figure 13: East end of Shudrick Lane at Walnut Close.***

This photograph was taken close to where the road ends and the fields begin; the surface water floods down the road and into Ditton Street (which is half a metre lower than the top of the town culvert in Shudrick Lane) where it floods homes and shop premises. This roadway leads into fields where the area is in Flood Zone 2-3. On the right, on the other side of the wooden fence, is the Shudrick Stream.

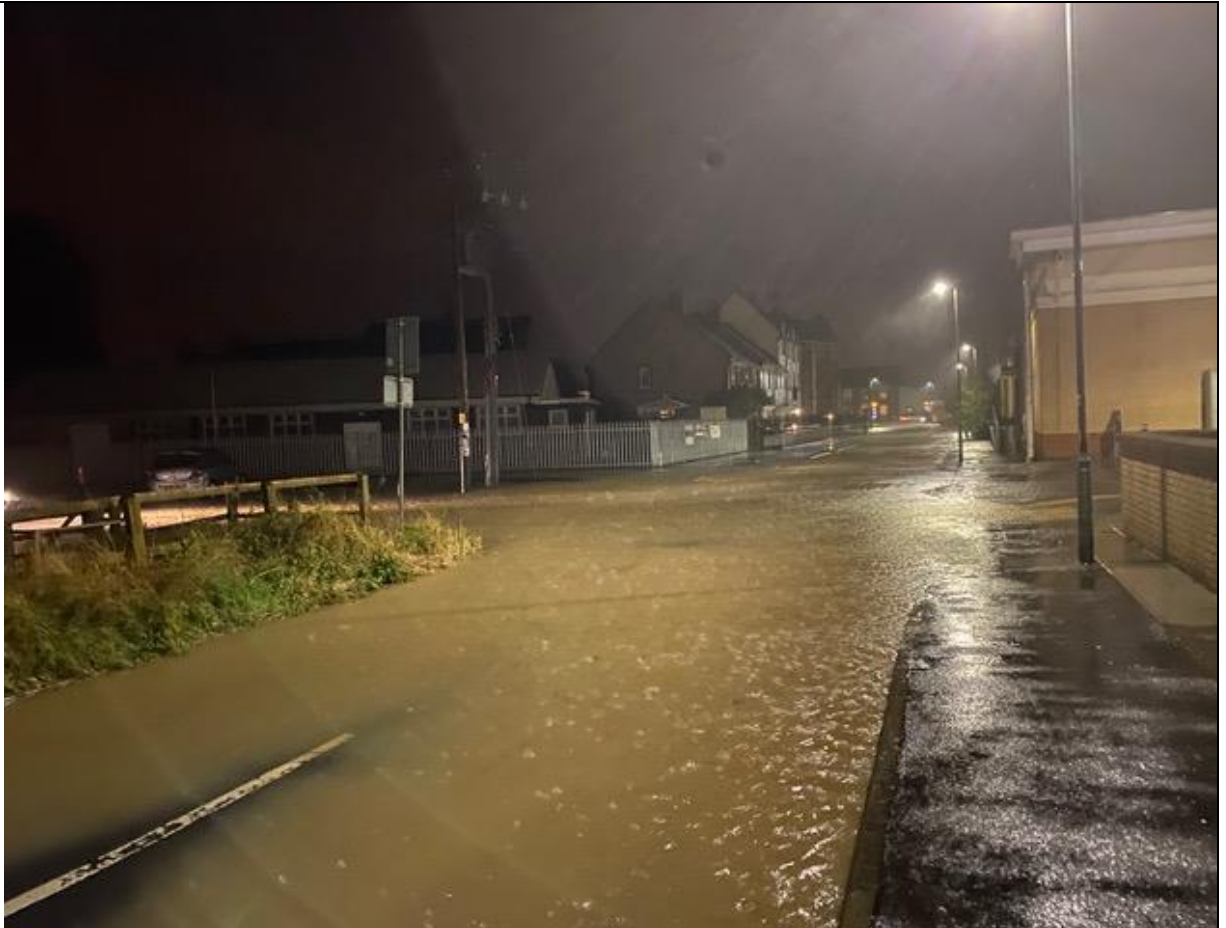
**Figure 14: Looking west down Shudrick Lane.**

Tesco car park is on the right, just outside of the photograph, and there is a small car park on left. Further to the left is the Swanmead school playing field, part of which also flooded. The entrance to the small car park, where the wooden fence ends, is the start of the town culvert on the Shudrick Stream.

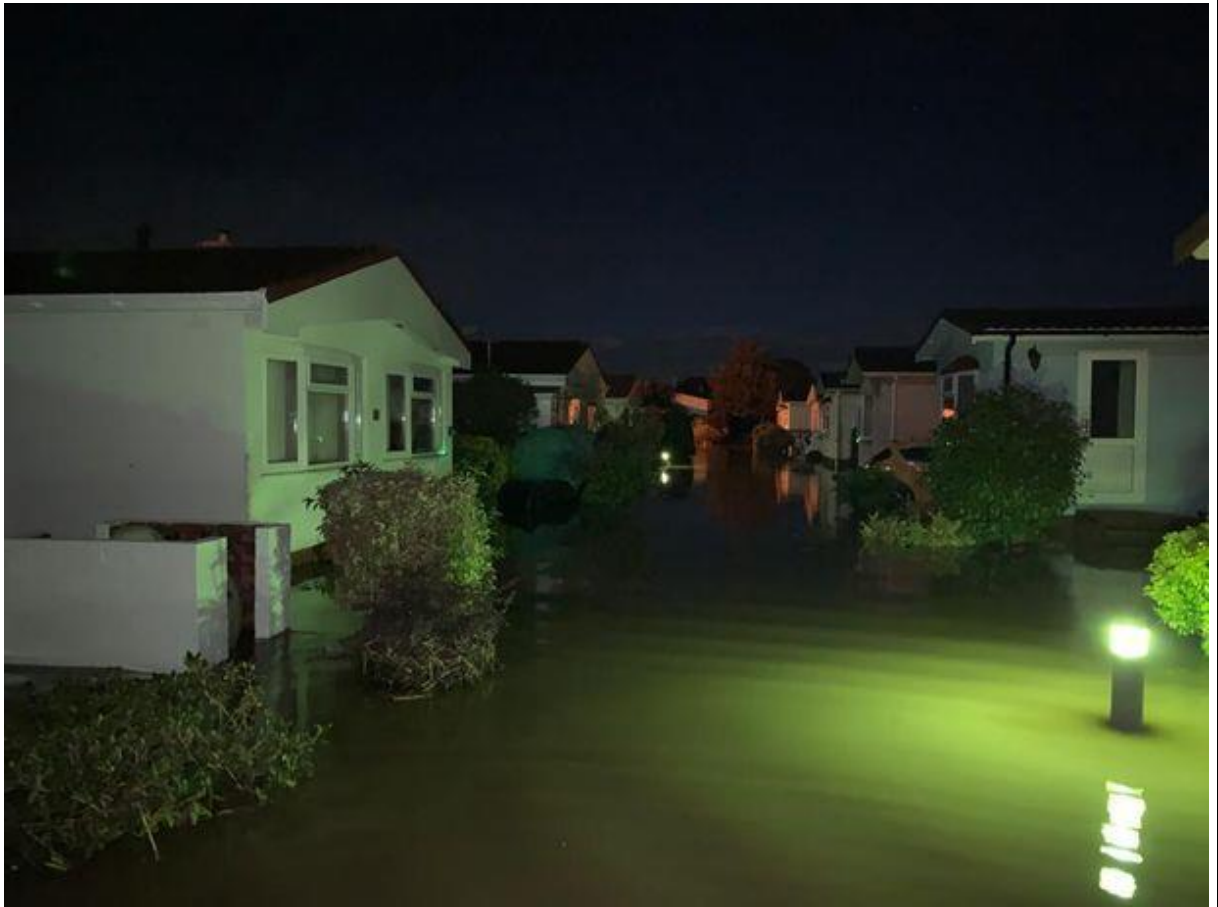
**Figure 15: Holway House Park**

**Holway House Park** was one of the worst affected areas with depths of water being described as up to 1.25 meters. Around 19 of the park homes were flooded internally, with nine being damaged beyond repair. A further 13 properties along Green Lane and three in Home Farm Way flooded with depths to around a metre. Thanks to its elevated ground level, none of the park homes in Home Farm Park were flooded internally, although there was external damage to garages and vehicles. There were an additional three commercial properties flooded in the Rose Mills Industrial Estate, which is on the left bank of the Isle upstream of Hort Bridge. From the damage witnessed in the buildings it was evident that there were water depths of up to 10 centimetres.

There are defences on the river Isle upstream of Hort Bridge which are maintained by the Environment Agency. It is believed that there was some outflanking of those defences at the very upstream end, and that this is the first time that has happened since they were built in the 1970s. On the night, park residents were lifting manholes to get water to drain away – but these are thought to have been sewage manholes so doing this would have caused and/or added to flooded sewers elsewhere.

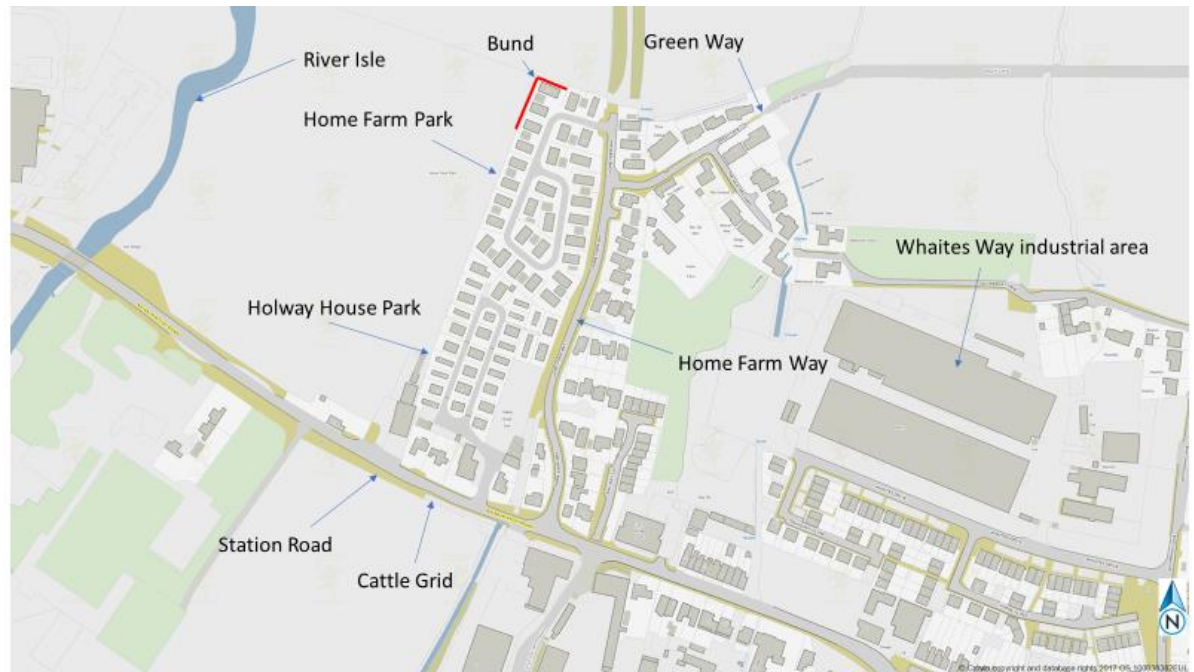
**FIGURE 20: BUND LOCATION.**

Within the residents' testimony of the flooding to Home Farm Park and Holway Park there were many references to 'the bund behind Home Farm Park'. Investigation has revealed some of the history and detail of this bund, and a cattle grid installed around the same time on Station Road.

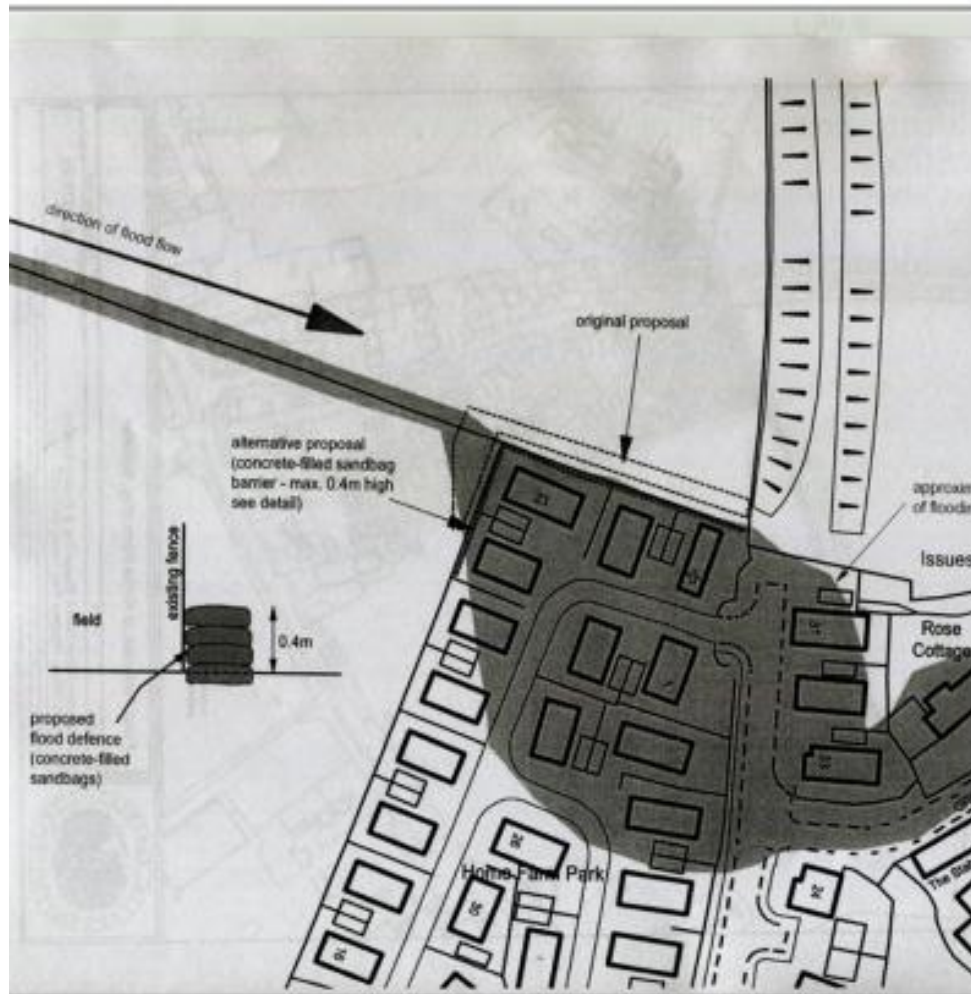
**Figure 21: Proposed bunds at the back of Home Farm Park.**

The deep grey area shows the area flooded in 2008.

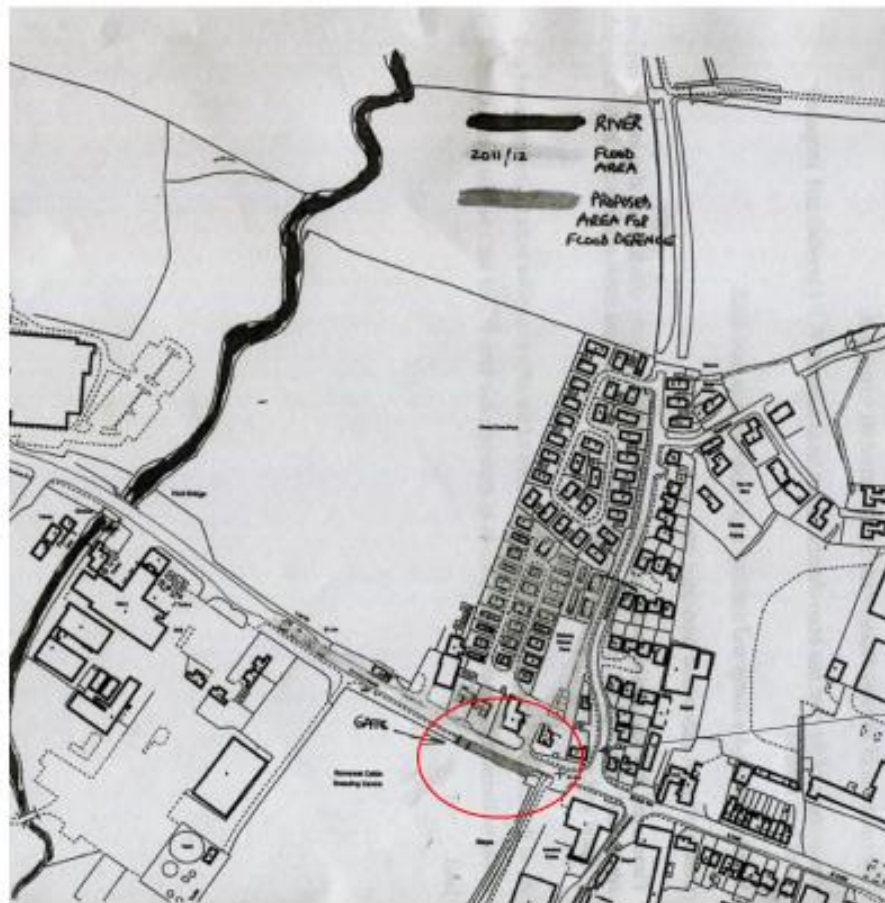
**Figure 23: Proposed cattle grid and ditch on Station Road.**

Further works were proposed to install a cattle grid structure next to the drainage ditch on Station Road, designed to divert water coming across the field away from the main Station Road surface, and down the ditch that runs alongside the old station area.

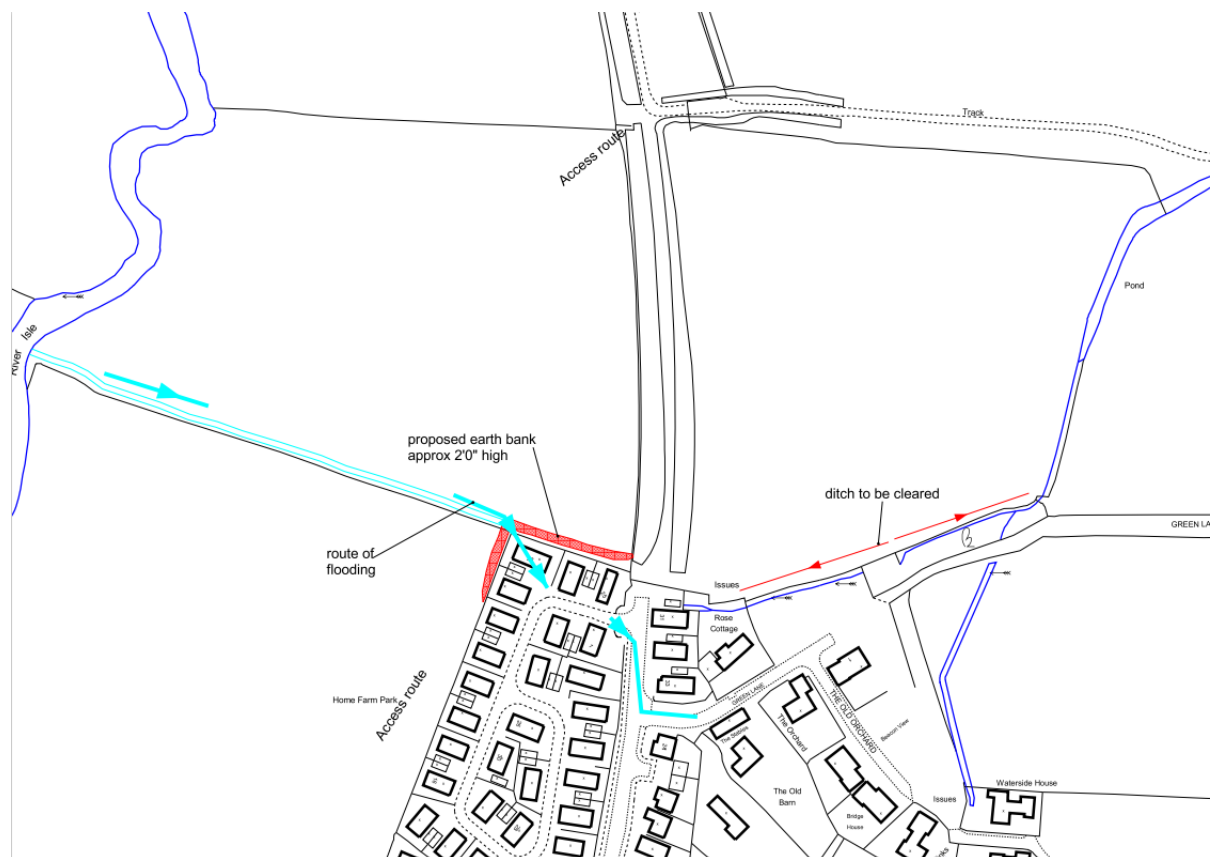
**Figure 24: Design records for Bund around Home Farm Park, SSDC.**

unfortunately full details of the proposed bund were not included. As originally applied for to Somerset County Council, it had a central core of sacks of concrete, with an earthen bund of unspecified original height over the top. However, it is not known whether this was how it was actually built, nor what the design parameters of the bund were; it appears to have been constructed in response to floods in the area in 2008, but it is not known whether it was designed to withstand, for instance, a 1 in 100 year rainfall event, or another parameter.

The land that the bund is on belongs to Dairygold, however it appears that their land agents were unaware of the bunds existence. Residents around the Home Parks, Green Lane and Old Orchard have produced various records around the construction of the bund. They state that the bund was constructed by SSDC on 23<sup>rd</sup> September 2014, over the course of a single working day, using bulldozers. They state that the scheme was designed and supervised by an SSDC engineer, now retired. Another officer who worked alongside this engineer, and still works for SSDC, has managed to track down some paperwork relating to the original installation.

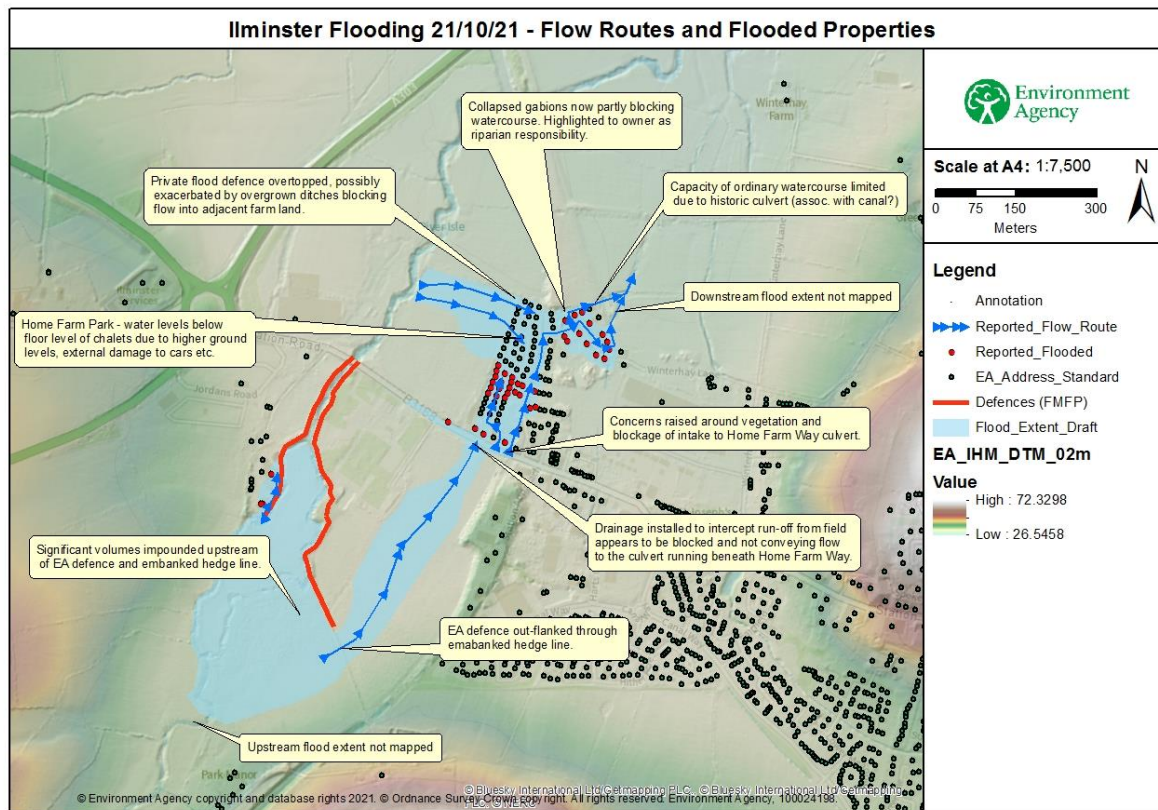
**Figure 29: Flow paths at the west end of Iminster. Source: Environment Agency, November 2021.**

The information in this map represents an outline estimate of the flood mechanisms and flooded properties during the flood of 20/21 October 2021 on the west side of Iminster. It is based on information gathered in the aftermath of the flood and may not be a complete and accurate summary, but is based on the best data and resource available at the time.

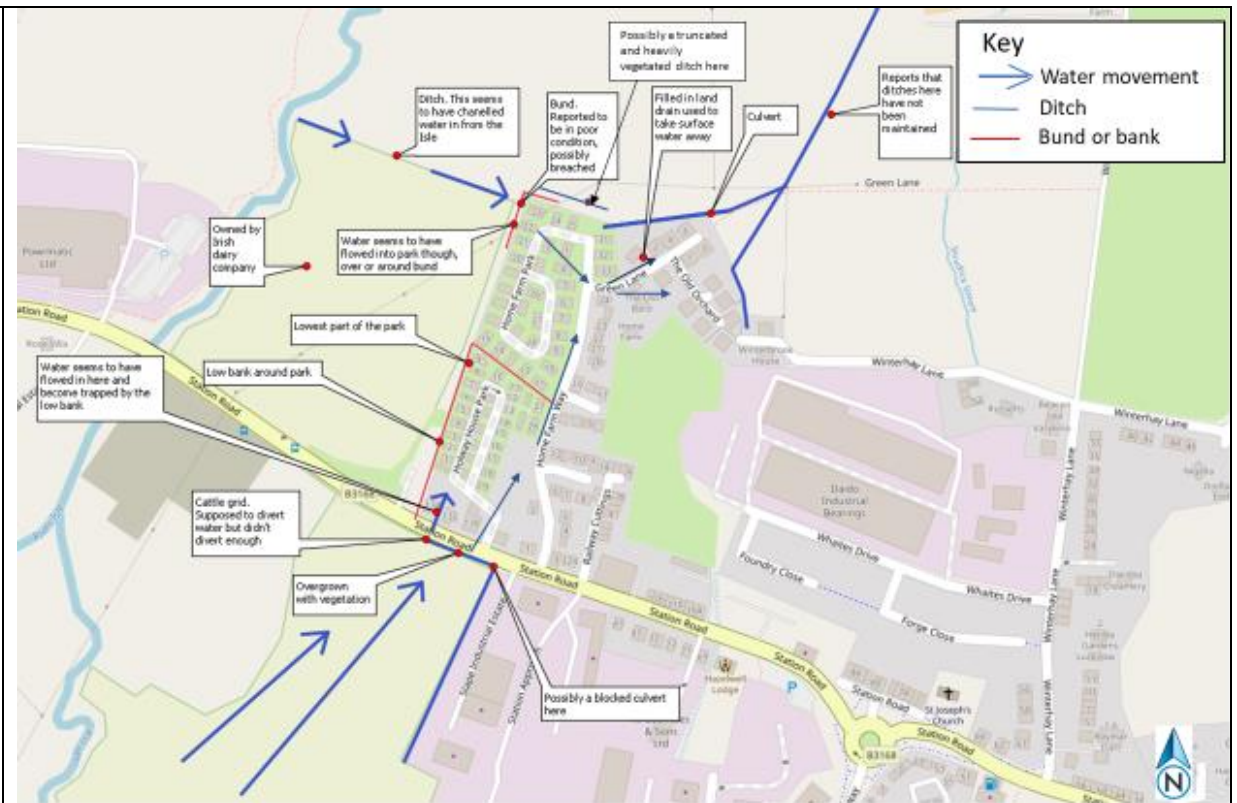
**Figure 30: Further detail of west Ilminster**

Most of the volume of water has come from the river Isle. The river spilled over its banks both to the north of the Hort bridge, and around the flood defences to the south of the bridge. Water from the northern spill flowed up over the field, to the west of Home Farm Park. From here it flowed through, around and/or over the bund into Home Farm Park, and across into Green Lane. Water coming up from the south combined with pluvial flow across the fields, flowed into and over the cattle grid, and across Station Road into Holway House Park and the houses next to it. This water was trapped in situ by the low bank around the park. Another portion of the water that came up from the south flowed across Station Road and across into Home Farm Way. This flowed down Home Farm Way to join up with the water from the north in Green Lane and the Old Orchard.

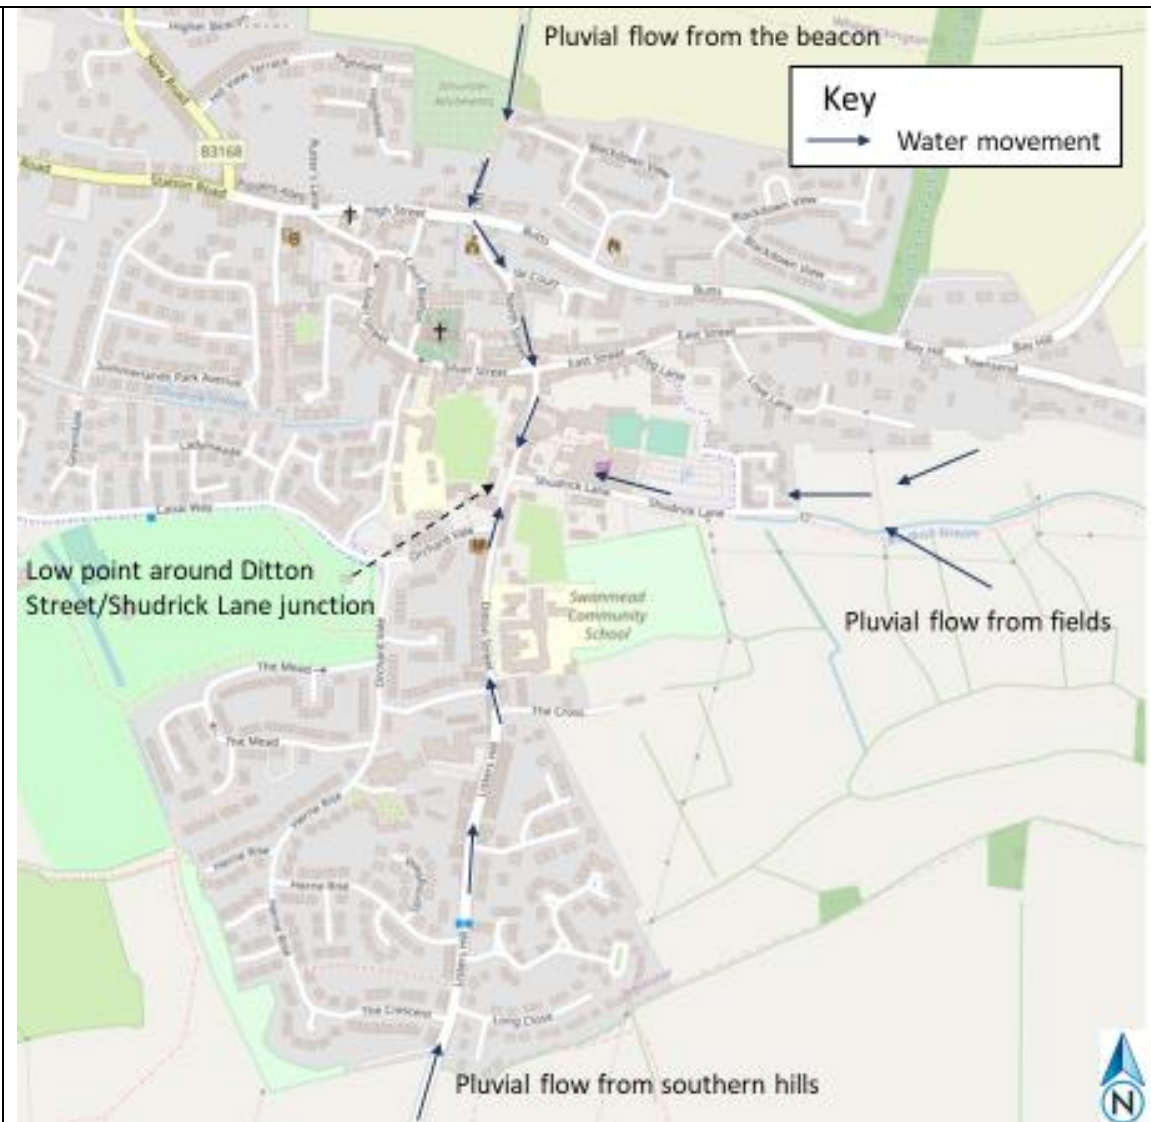
**Figure 31: Pluvial flows around east Iminster**

Pluvial flow from the hills to the north and south of Ilminster flowed down into the centre of town and gathered in the low spot at the junction of Ditton Street and Shudrick lane. Flow from the north came from Beacon hill, down the track past the allotments, along Old Road and into North Street. Water heading into town from the south flowed down Listers Hill and into Ditton Street. Rainwater also flowed in from the fields to the east of Ilminster and down Shudrick Lane, where it again collected at the low point. This was added to by water from the Shudrick Stream itself, which came out of bank, possibly due to the culvert that leads under Ditton Street becoming blinded with debris or overwhelmed by the large quantity of water.

EA, local residents and Councillors observed these flow paths, and also that the pluvial flow comes off fields, carrying soil, stones, and debris with it. This will tend to collect in and possibly block drains during an event. Long term local residents also observed the high volumes of water coming from these sources, and said that they felt even free running drains would not have coped with all of it.
