## Section 19 Investigation Report

<b>Date of Incident</b>	28 <sup>th</sup> June 2021	<b>Date of Report</b> <b>Version</b> – 5.4 21.09.2022 <b>Status</b> all corrections added
<b>Site / Catchment Location:</b>	Chard, Combe St Nicholas / Wadeford, Wambrook, Nimmer, Tatworth & Forton, Chaffcombe

This report covers the heavy rainfall incident on 28<sup>th</sup> June 2021, and the subsequent flooding in Chard and surrounding villages and hamlets.

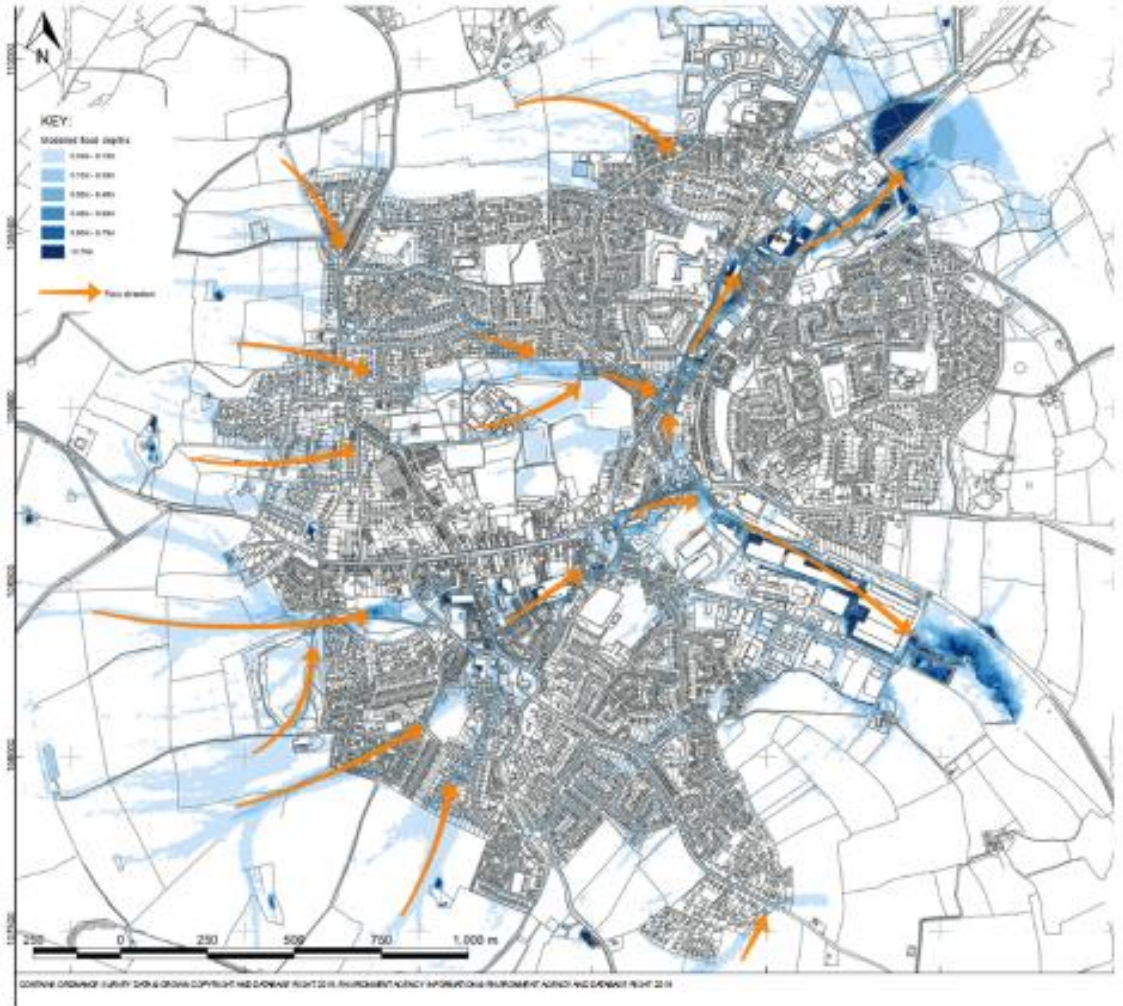
Modelling of flood flows in Chard has provided a map of the likely water movement during the event, which corresponds with reported experience on the ground. The map below (figure 9) is representative of a 1 in 375 year rainfall event, and so is somewhat more severe than the 1 in 300 event experienced. However, the flow directions seem to hold true, even if the extents of flooding shown are a little greater than what actually occurred.

***Figure 9: Model mapping of 1 in 375 year rainfall event and resultant fluvial and surface water flooding.***

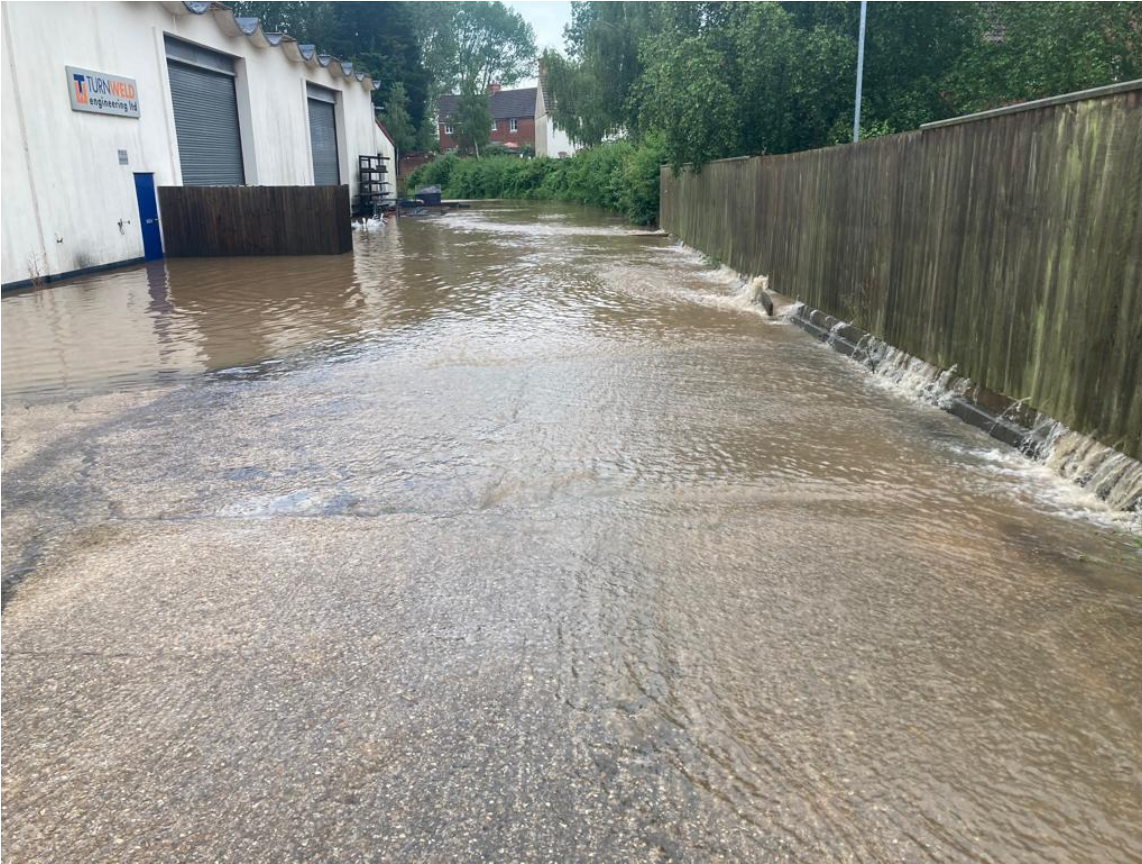
***Figure 20: Surface water entering Furnham Road Industrial Estate from Coker Way, a residential area to the south. Photo supplied by Turnweld Engineering.***

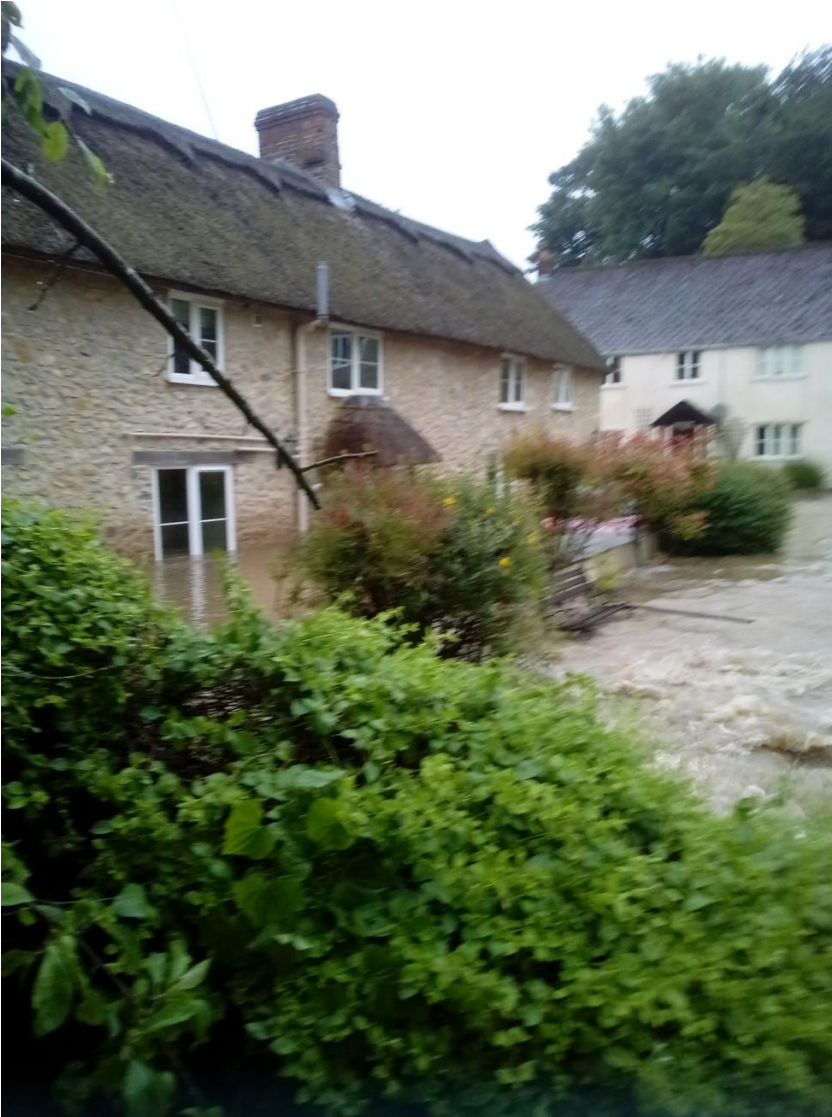
***Figure 22: The front of a house on Court Mill Lane – note that the water is up over the window ledges. Photo supplied by Parish Clerk.***

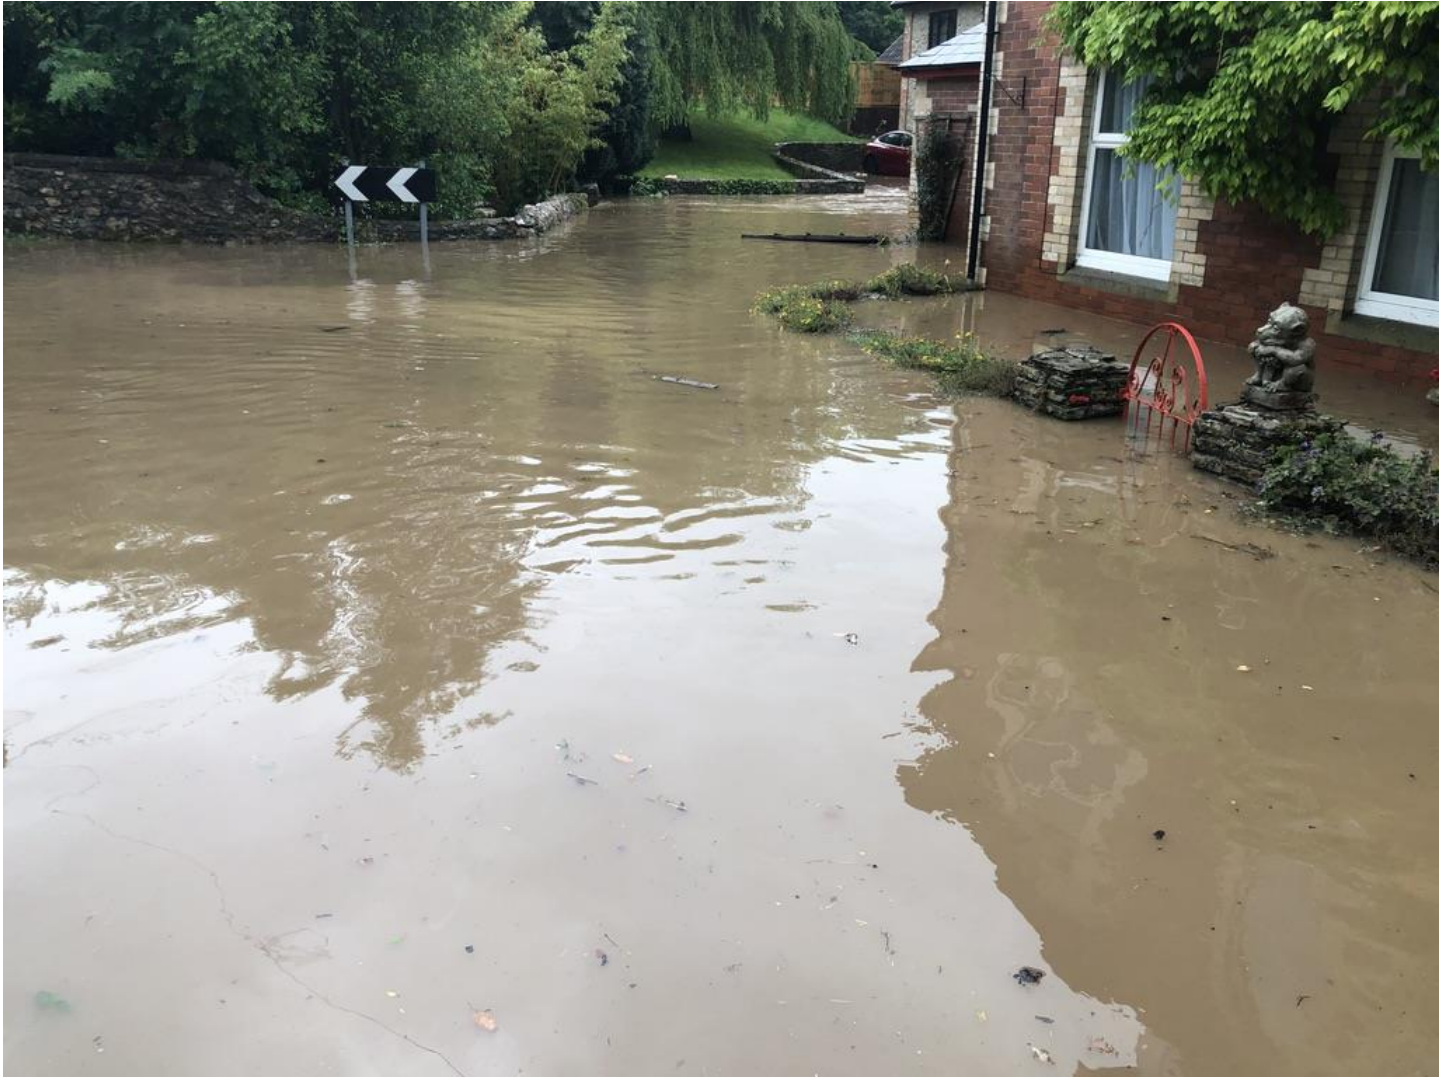
In **Wadeford** the road flooded outside Goblin Hollow. The culvert was reported as being partially blocked. They also reported that gullies outside are either damaged or have been buried within the access road. During the flood there was a sudden rise in water level in Wadeford, and this has led to allegations within the village that it was linked to the breaching of containment of a series of ponds of fairly recent construction.

***Figure 23: Main road around Goblin Hollow. Photo supplied by Parish Clerk.***

- Have their owner identified or confirmed.
- Be checked for damage or blockage.
- Be repaired and/or cleared as necessary.
  - Flood alleviation feature at the back of St Marys Close, Chard.
  - Culvert and trash screen in the open area in Glynswood.
  - Drain or culvert on Bews Lane.
  - Culvert in Dellshore Close.
  - Culvert(s) in Nimmer, reported as being installed by the council in 2009, and/or under MAFF funding in the late 1990’s.
  - Culvert and gullies near Goblin Hollow, Wadeford.

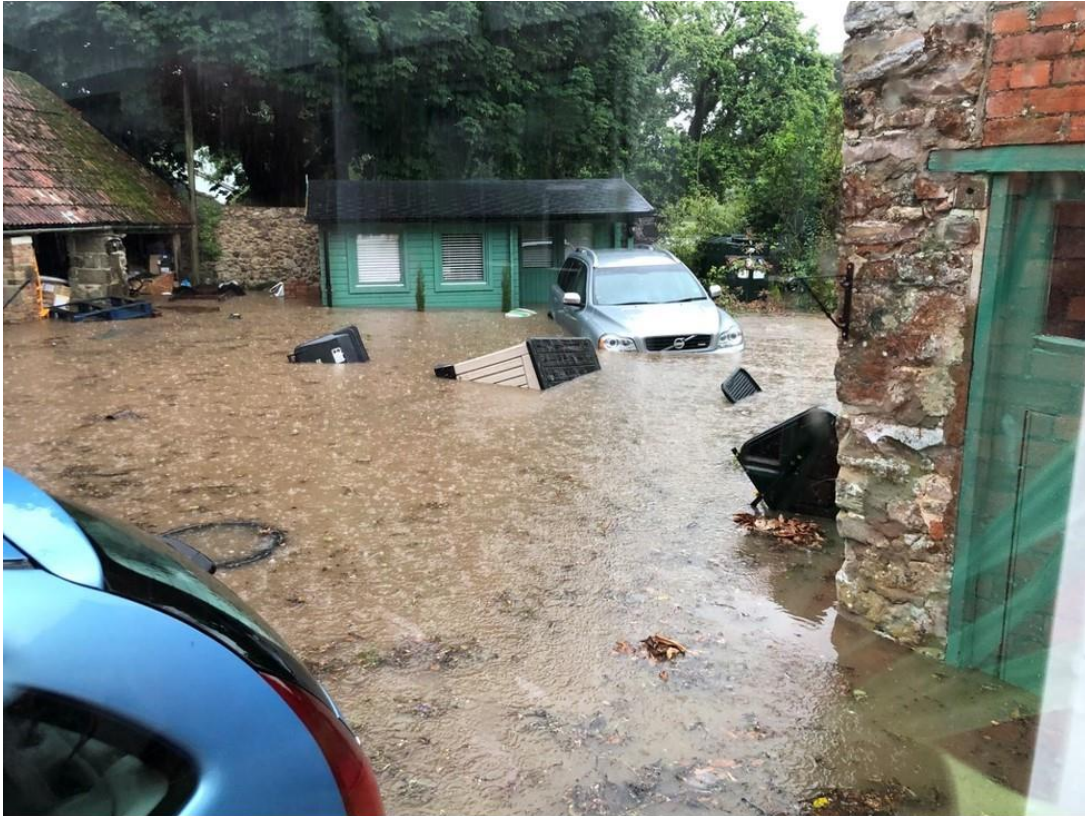
***Figure 24: Back Garden of a house at Chapel Triangle, Wadeford. Photo supplied by Parish Clerk.***

Flooding in Wadeford rose extremely high in places, and water ran down the sloping streets to the bottom of the village with considerable force and speed.

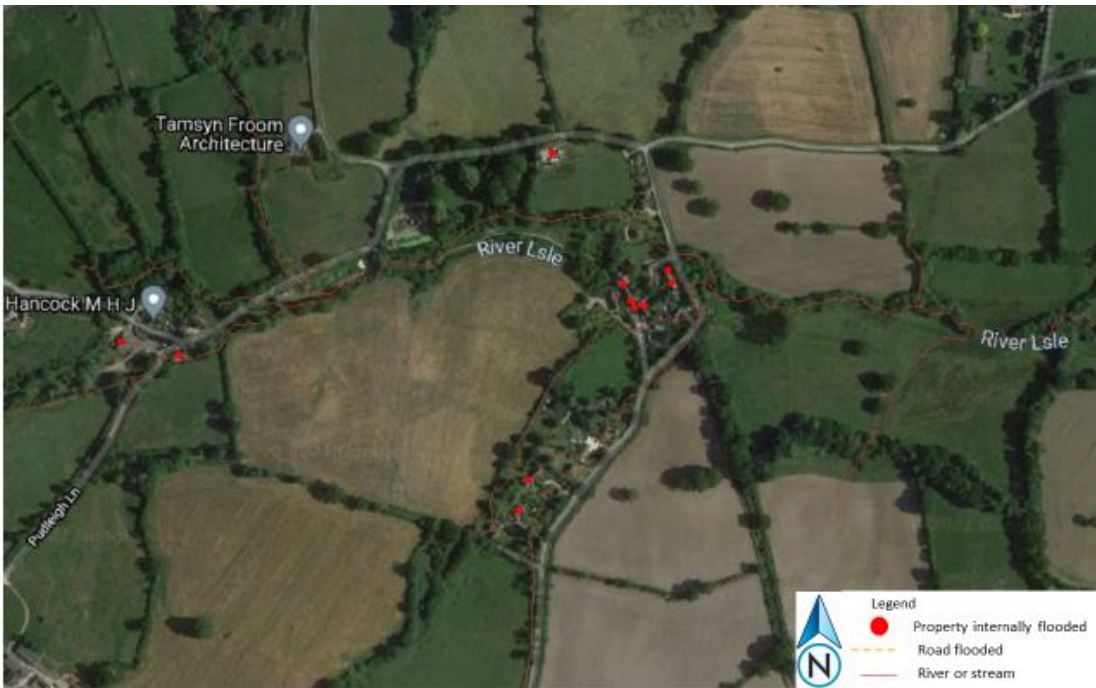
**Figure 26: Flooded properties in Nimmer.**

Again, here the main flooding mechanism, as reported by the Parish Council, was the overland flow of surface water from nearby fields to a topographical lowpoint. Residents near the river explicitly stated that they were flooded from overland flow, not from the river rising. Blocked drains and blocking of a culvert installed in 2009 were implicated as contributing to the problem.

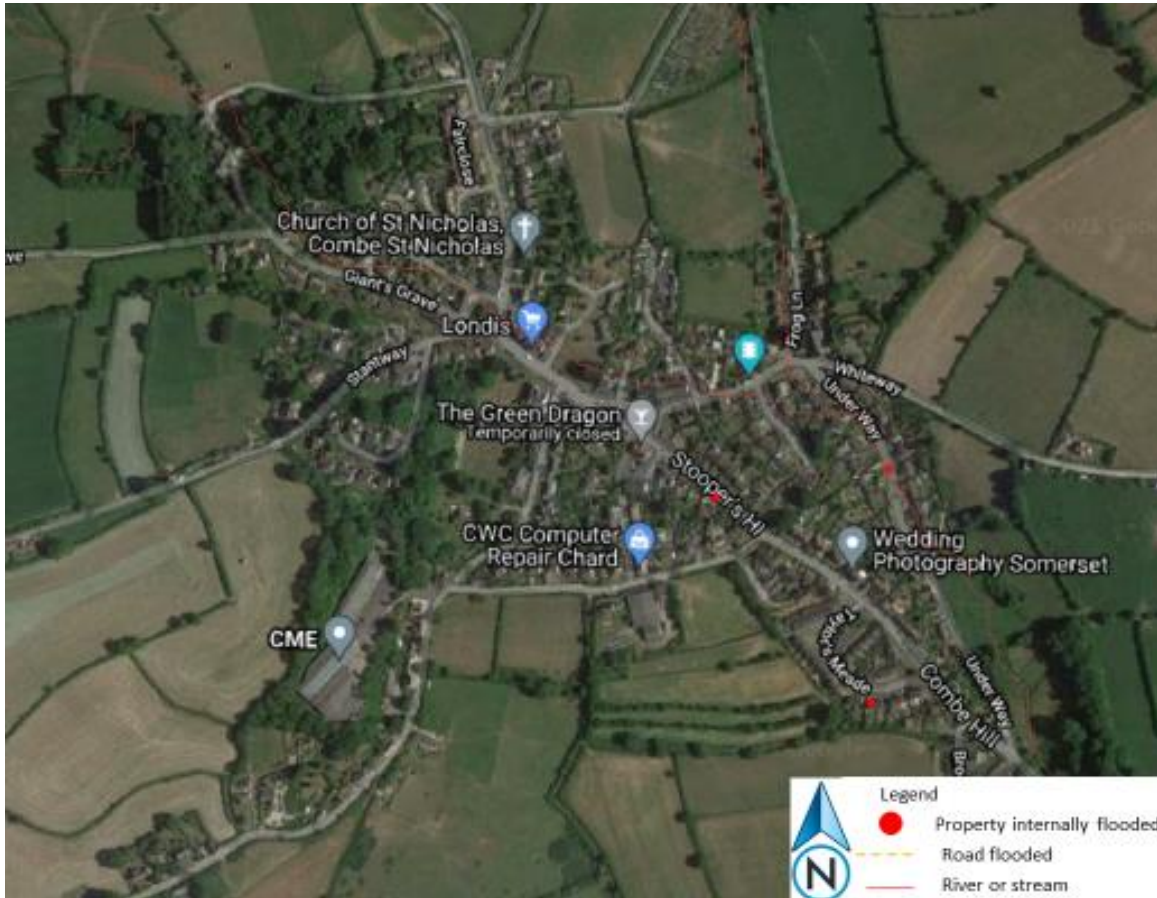
**Figure 27: Flooded properties in Combe St Nicholas**

The main mechanism of flooding here, according to Parish Council reports, was surface water running downhill off of nearby fields, and down Wadeford Hill / Combe Hill. The village is at a topographical lowpoint. They also reported that the watercourse in the centre of the village rose in level, and that some properties were affected by both flooding mechanisms.

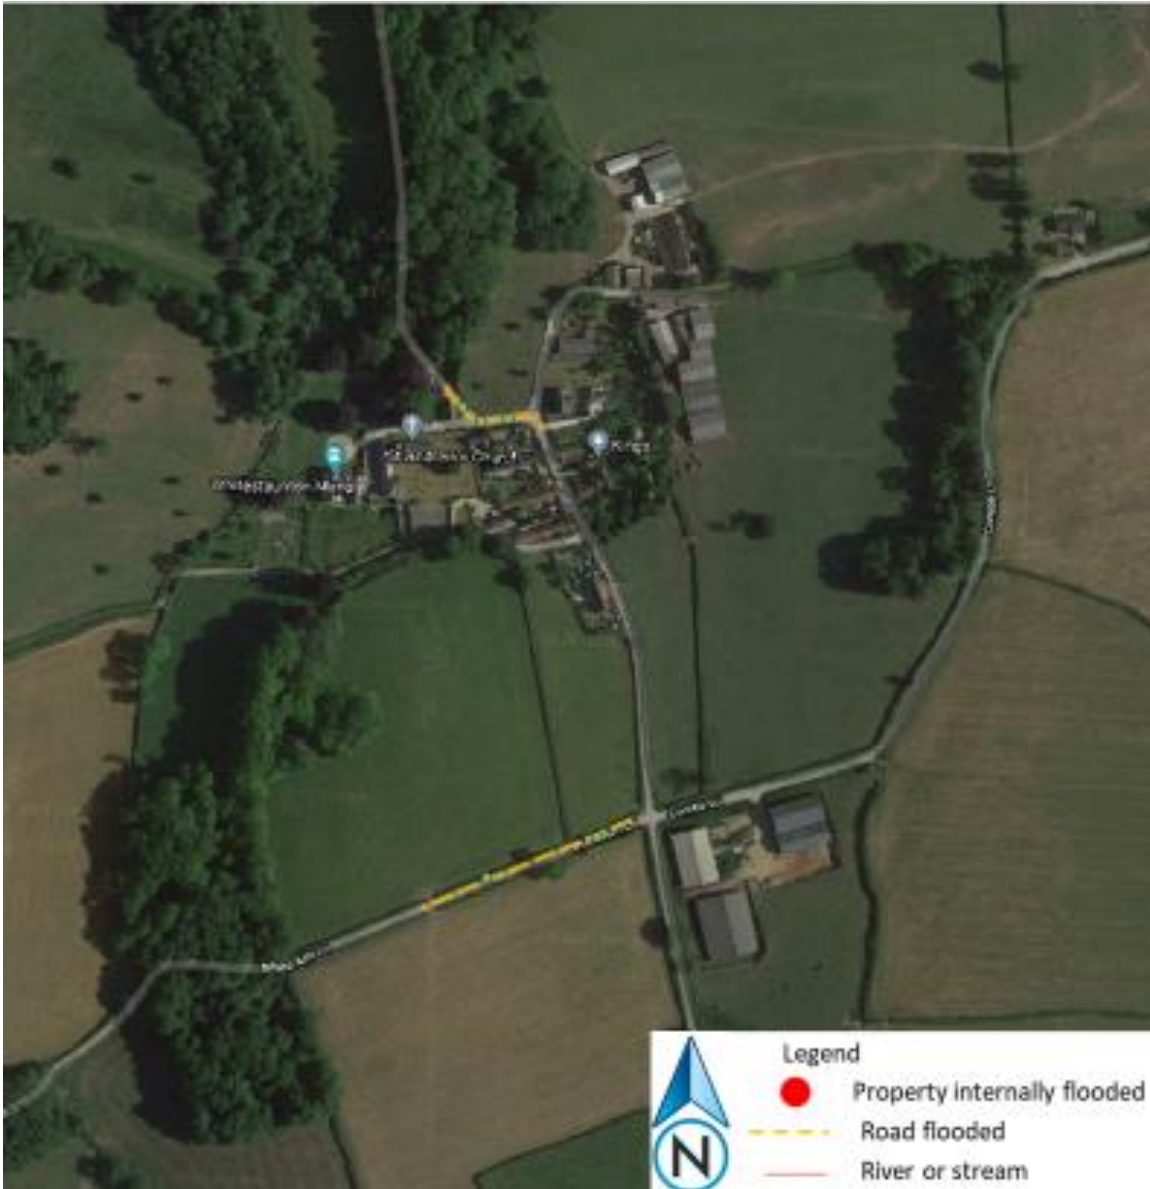
There have been no reports thus far of houses flooding in **Whitestaunton**, but there have been reports of extensive road damage. This has apparently resulted from the force of the overland pluvial flow down White Ash Lane and Mill Lane.

***Figure 32: Flooded areas and damaged roads in Whitestaunton.***

Note that the report for flooding and damage outside the settlement only named 'White Ash Lane'. The area shown is the steepest section, and therefore thought most likely to have sustained damage

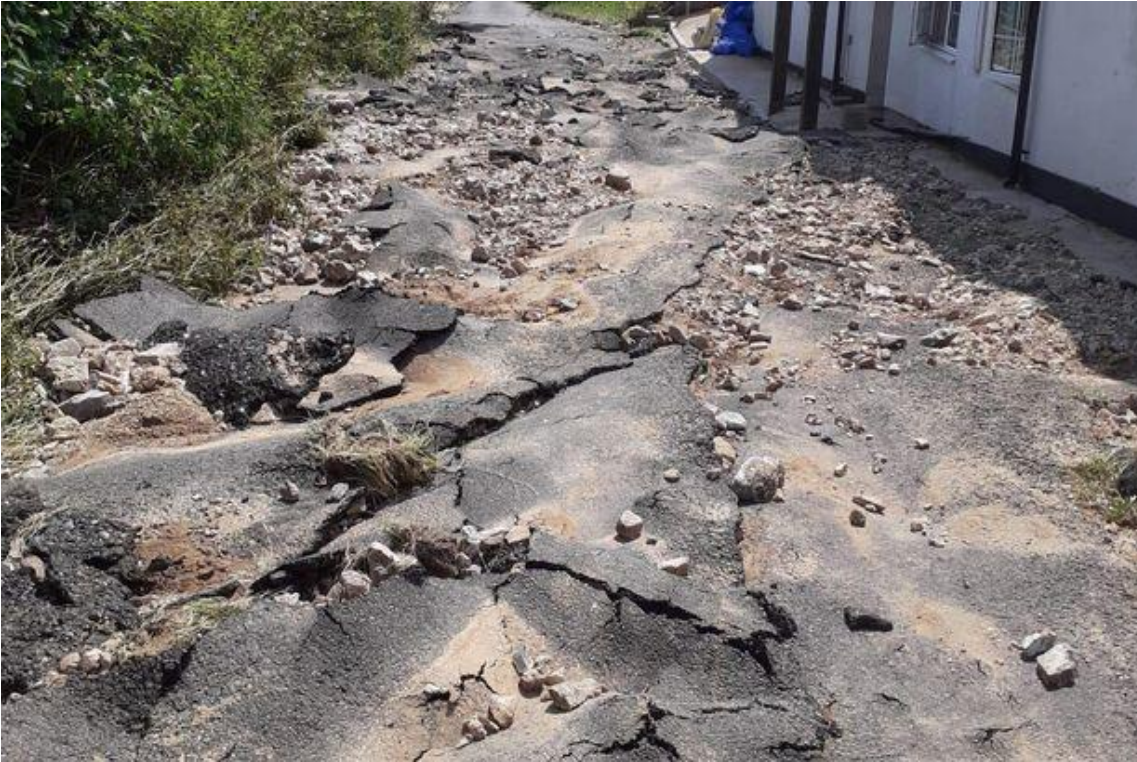
***Figure 34: Damage to Scampton lane. From***  
[Chard flooding aftermath leaves roads completely destroyed - Somerset Live.](#)

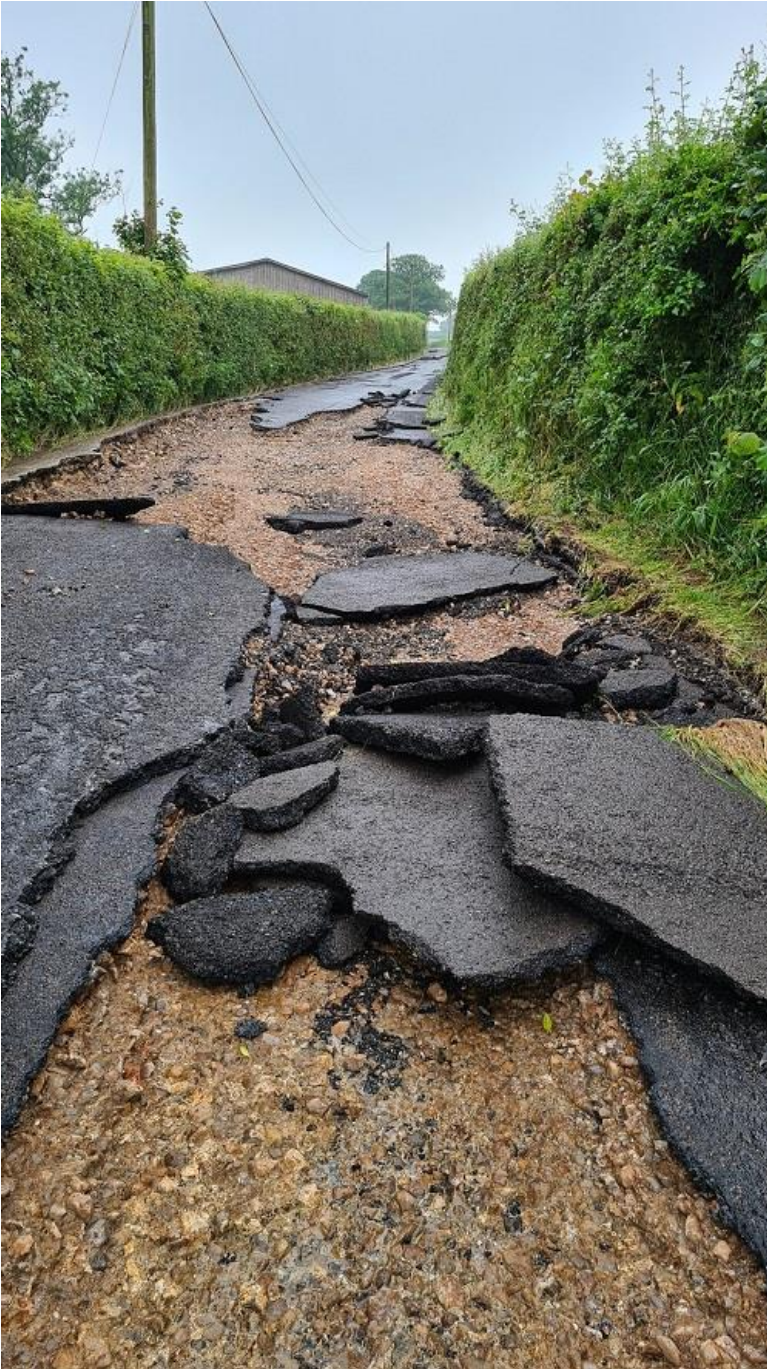
***Figure 35: Road damage in Whitestaunton. Photo from [Access restored as Highways teams respond to flash flooding damage](#) | Somerset County Council Newsroom ([somersetnewsroom.com](#)).***

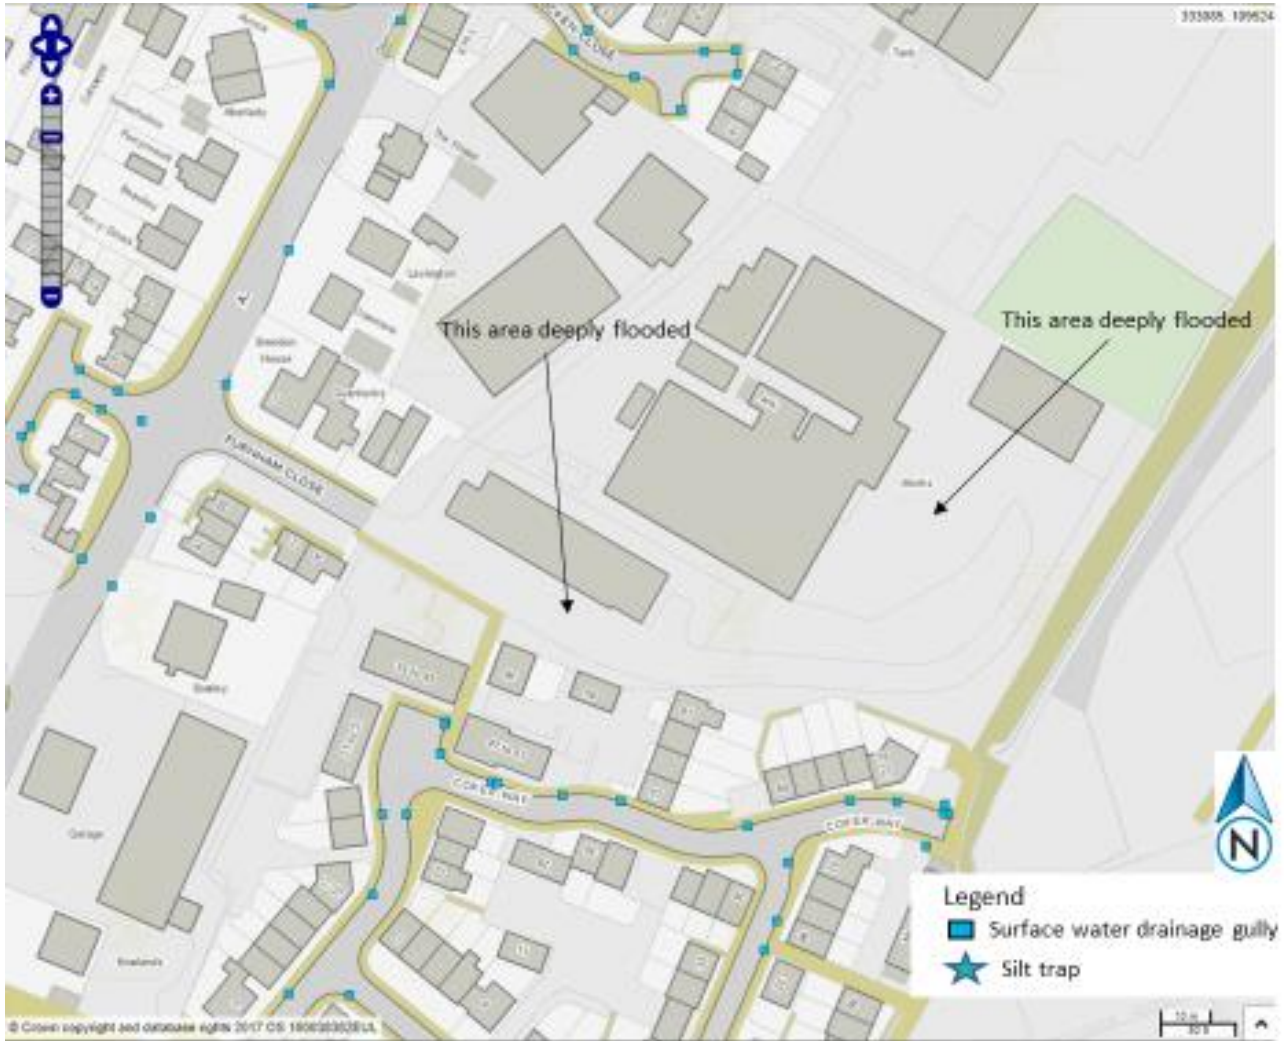
**Figure 38: Highways Surface water drains in Furnham Road Industrial Estate.**

The absence of any apparent gullies around the Furham Road industrial estate needs to be looked at and the location of private gullies recorded, along with their ownership.

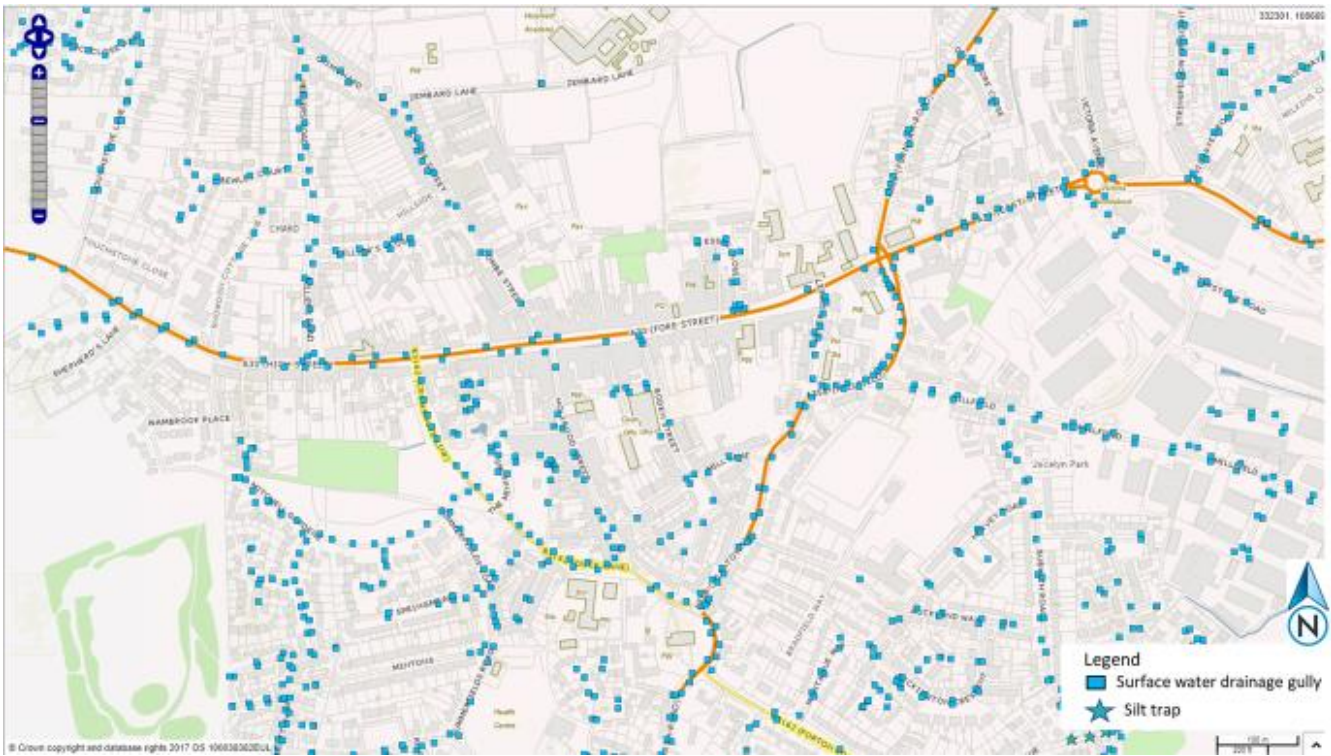
**Figure 40: Highways Surface water drainage around the High Street and East Street.**

There are large areas here with no apparent gullies. Again, this needs to be looked at and any gullies and their ownership recorded.

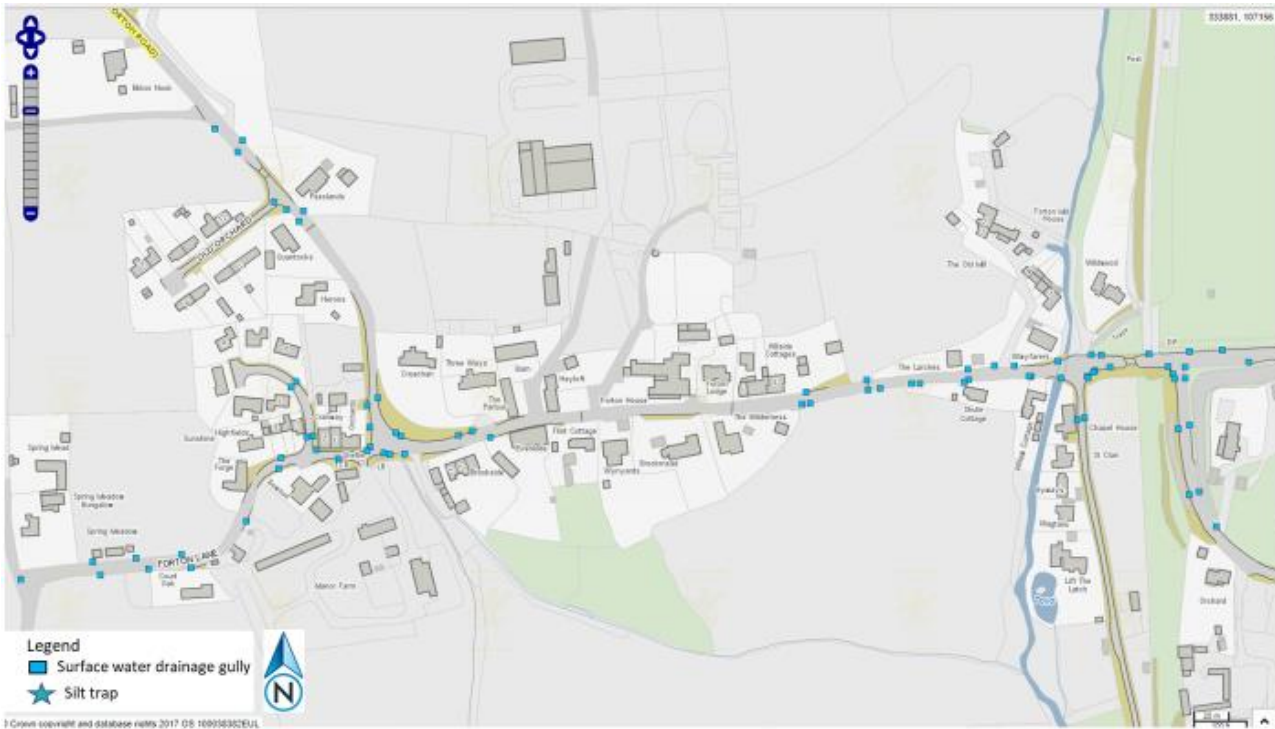
**Figure 44: Highways Surface water drainage in Forton.**

There are no gullies in the centre of the village. This needs to be looked at and confirmed.
