# Somerset County Council

### Section 19 Investigation Report

<b>Date of Incident:</b>	20 <sup>th</sup> October 2021	<b>Date of Report: 11th November 2022</b> <b>Version: 34.1</b> <b>Status:</b> adding feedback from park homes group
<b>Site / Catchment Location:</b>	Ilminster

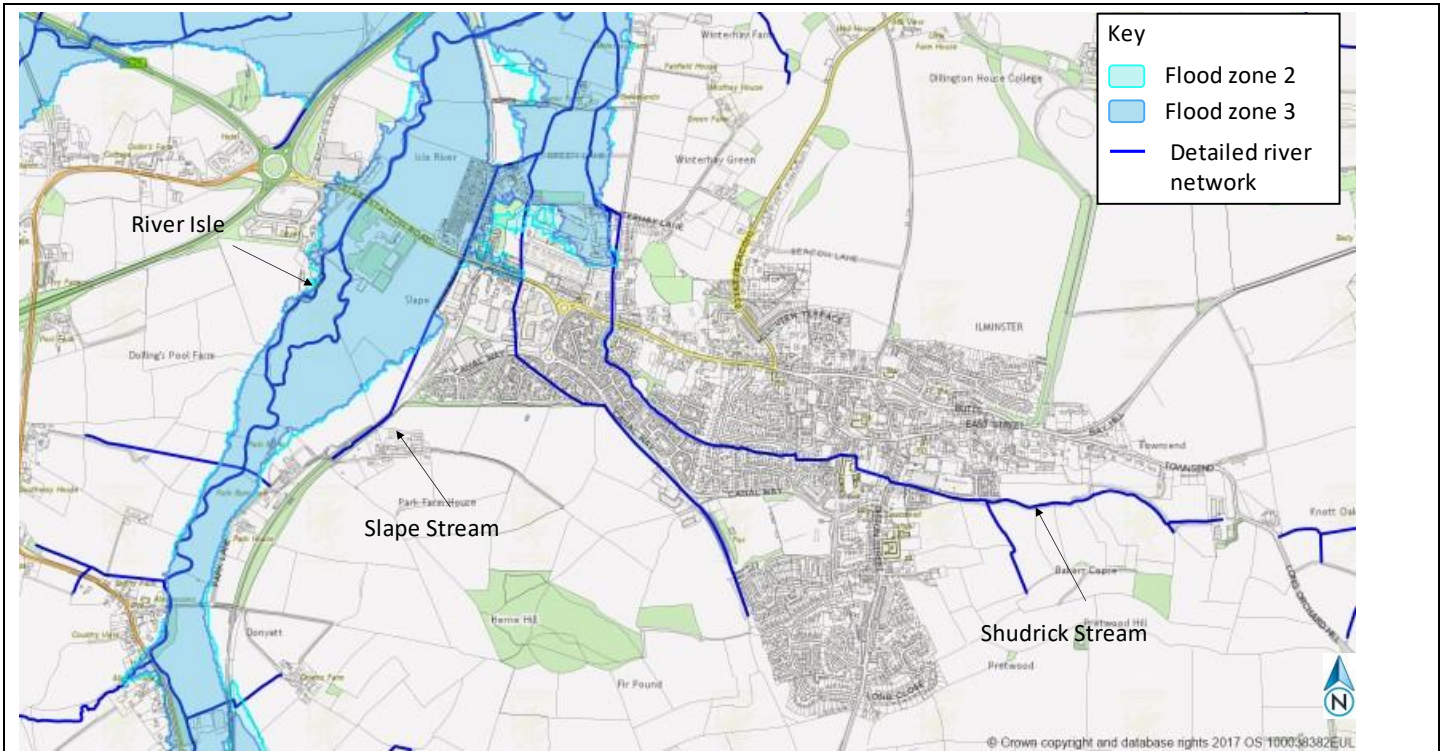
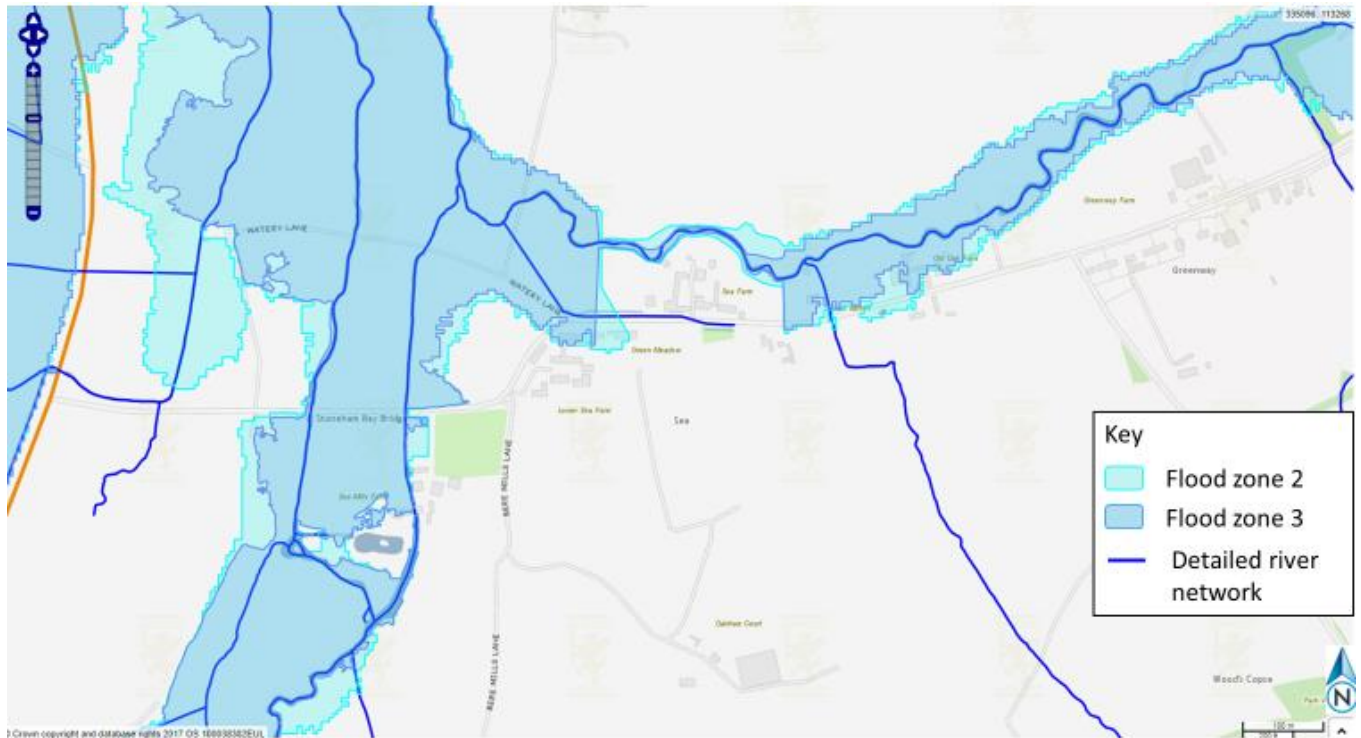
**Figures 3 & 4: Flood zones and detailed river network**

The above maps also show the risk of fluvial flooding – that is, from the river alone. Flood zone 2 consists of areas that have 0.1-1% chance of flooding from rivers in any year, and Flood zone 3 consists of areas that have a 1% or higher chance of flooding from rivers.

A member of the public has reported that the Figure 3 map above is incorrect, and that the old canal, which runs down the western side of Ilminster town, actually joins with the Shudrick Stream rather than the Snape Stream. This appears to be an issue with the Ordnance Survey map as well as the Environment Agency information from which the above figure derives. The path of this watercourse should be investigated and corrected as necessary.

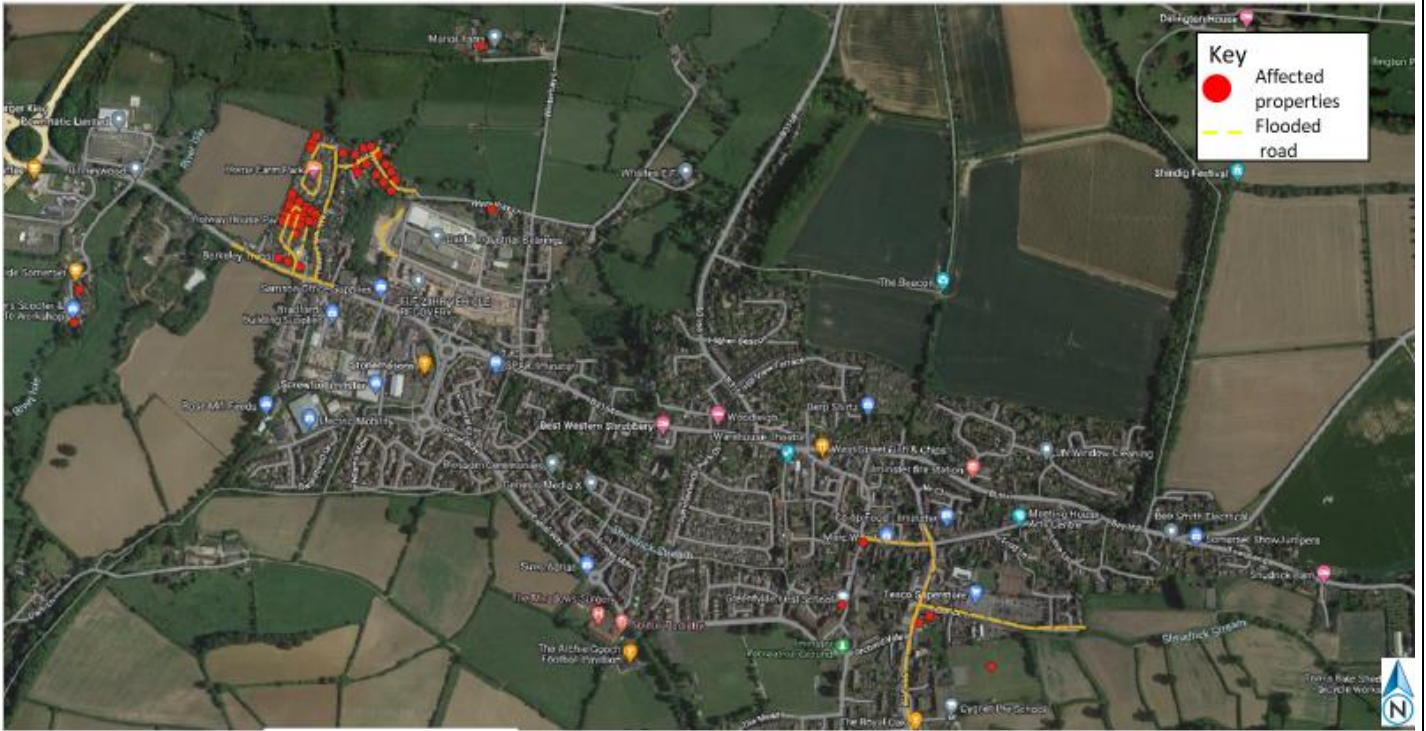
**Figure 6: Areas affected in Ilminster**

50 properties have been reported as flooding in Ilminster during the event. The actual number affected may be higher, as those affected sometimes do not report having been flooded.

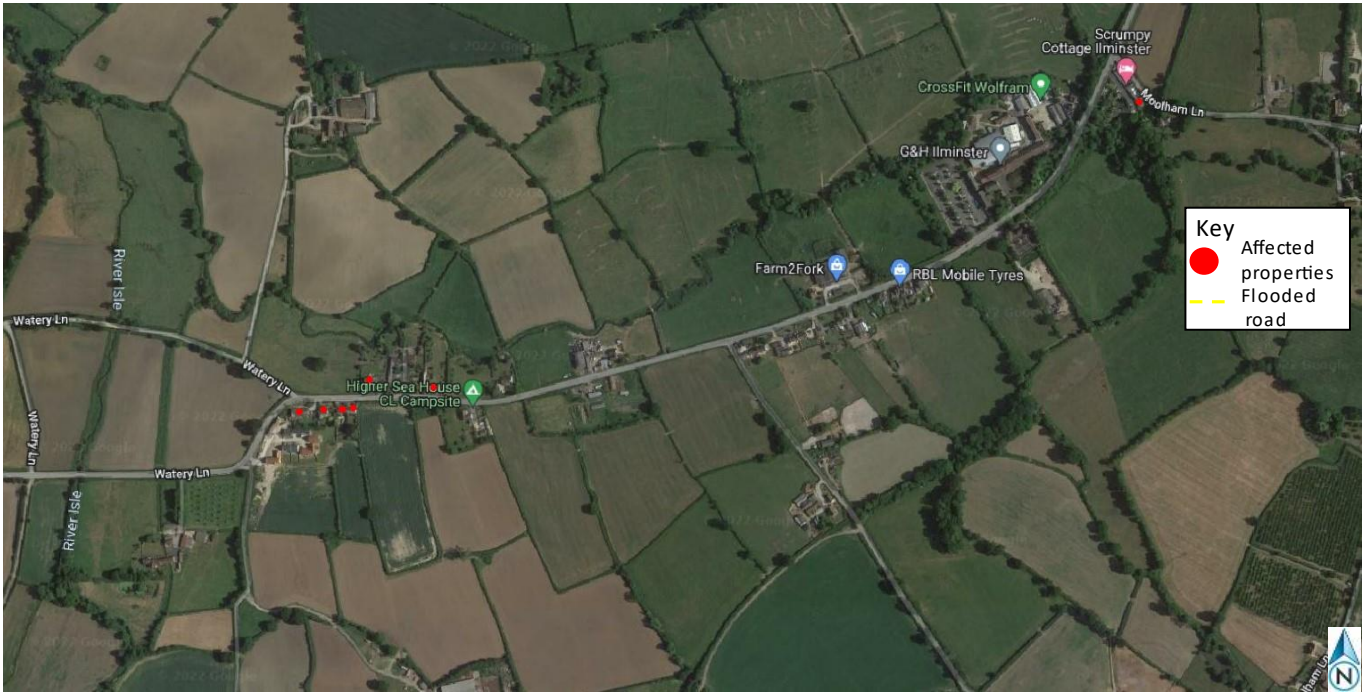
***Figure 7: Areas affected in Sea and Dowlish Ford***

Six Properties were reported as being affected by flooding in Sea, and one in Dowlish Ford.

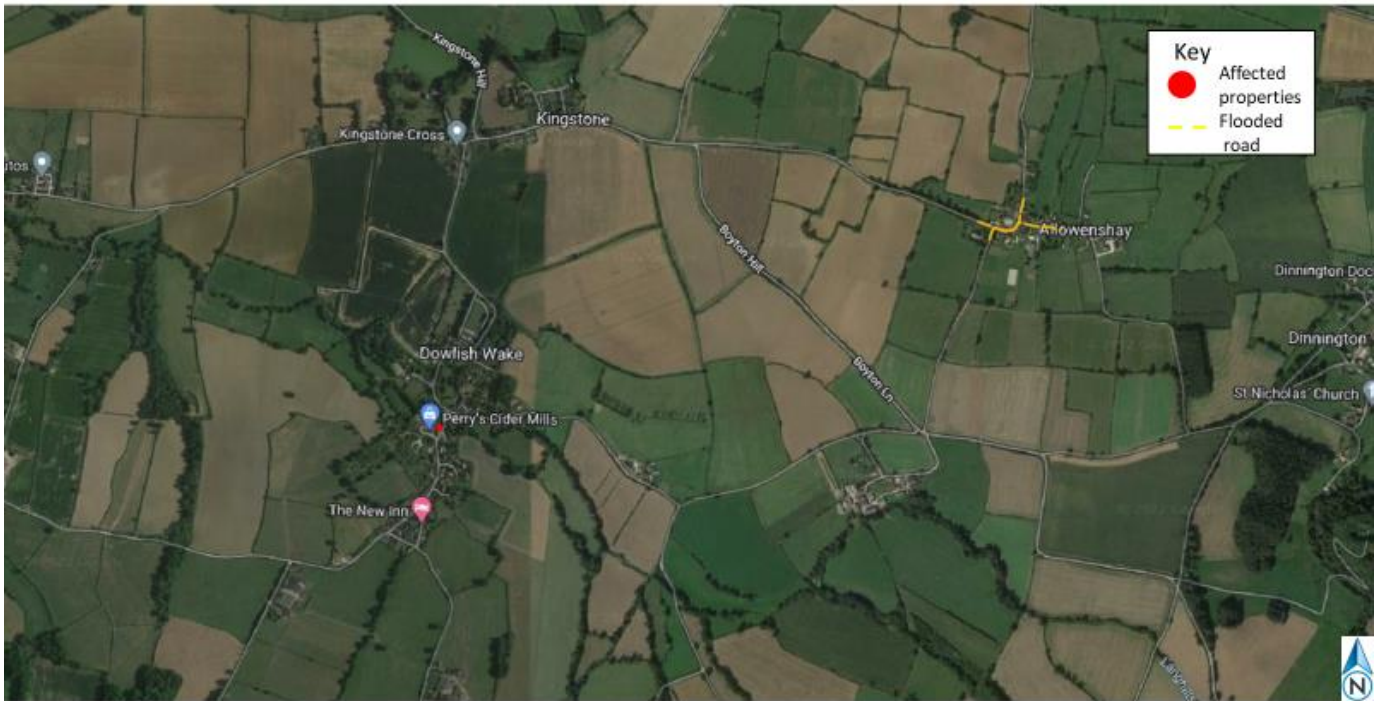
***Figure 8: Areas affected in Allowenshay and Dowlish Wake***

One property was reported as being affected in Dowlish Wake. Roads were flooded in Allowenshay. Horton Village was also reported as being badly affected, but no details have been received. These are the main areas reported as being affected by flooding in October 2021. Flooded farmland or forestry is not shown.

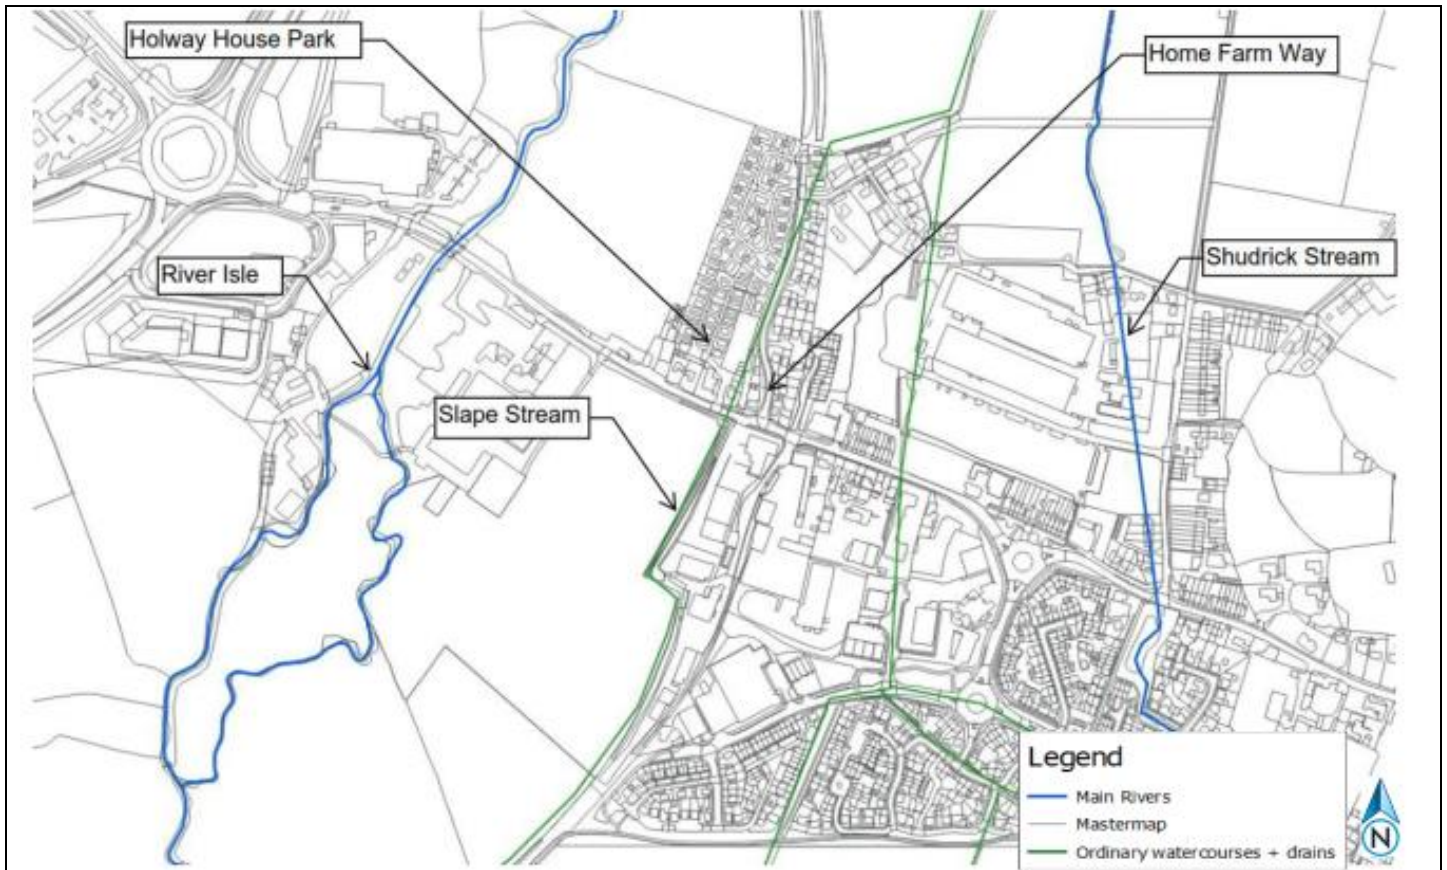
**Figure 9: Watercourses around the Park Home sites**

The two Park Home sites were particularly badly affected. Houses in Station Road, Green Way and Home Farm Way, and the Rose Mill Industrial Estate also experienced flooding.

Although the Slape Stream is marked on this map as running down Home Farm Way, alongside the residential parks, there is no sign of it on the ground until you get across Station Road, where it appears as a ditch running alongside the small industrial area on the old station site. It is not known whether this is a winterbourne, only appearing during periods of high rainfall, or whether the stream has been culverted under the park homes developments, and re-appears at the surface during high rainfall. The true situation may be a combination of the two.

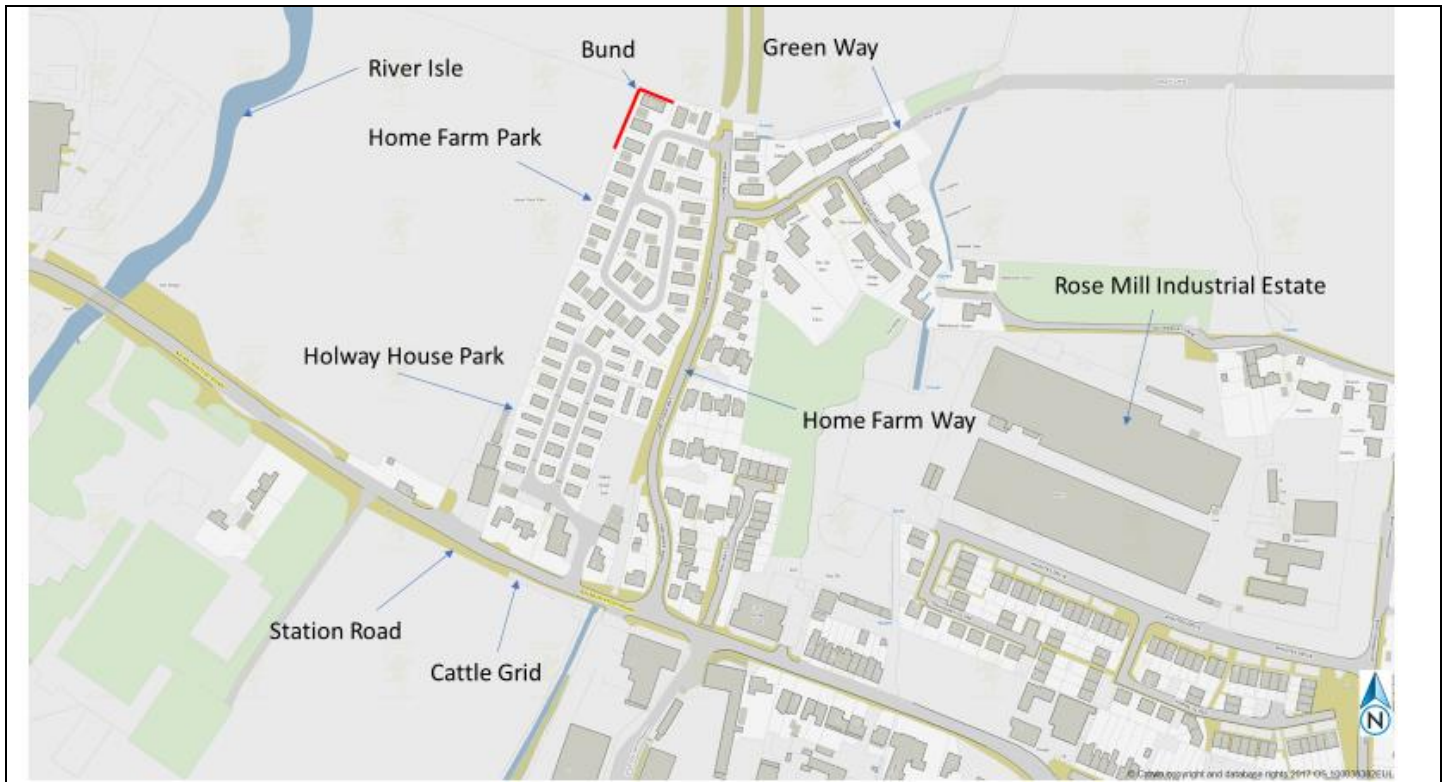
***Figure 10: Detail of Park Home sites***

The history and placement of the bund shown in Figure 10 will be discussed in a later chapter.

A resident has reported that "When viewed in person from the field to the North of the Park homes it's clear to see how the Park home gardens have increased slightly in size over many years flattening the Bund, filling the adjoining ditch and removing any usefulness of the original built bund.". There have been other reports that the bund has degraded, in various ways and for various reasons. Not knowing the original design parameters, it is difficult to say how much degradation has taken place. It may be better, rather than try and restore the bund to an unknown original condition, to ascertain what design parameter we wish to use and rebuild to that standard.

Further work needs to be done to understand the parties responsible for ownership and improvement of the bund around the Park Homes. The condition of the bund needs to be examined and improved or repaired as required.

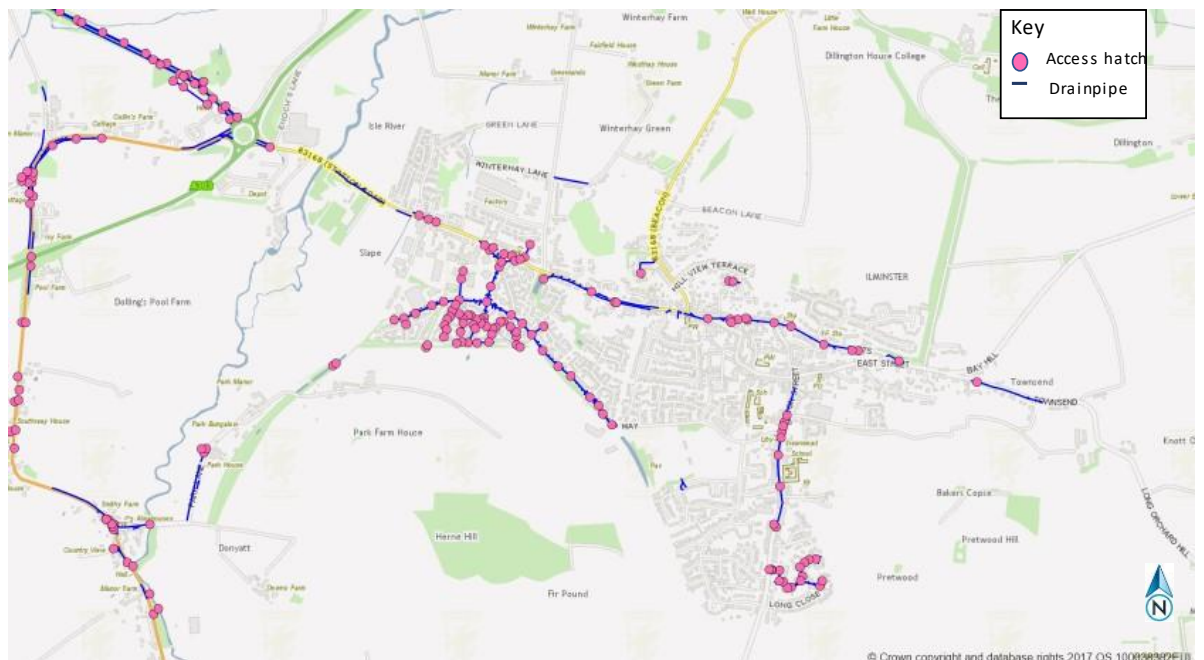
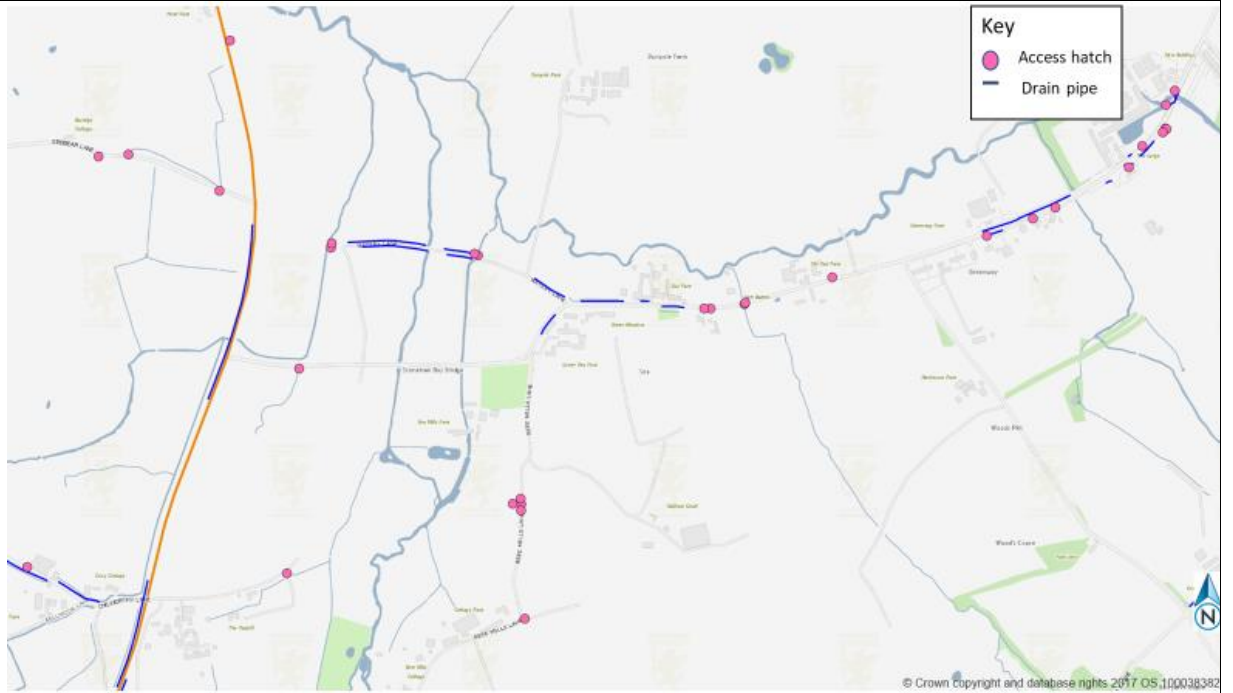
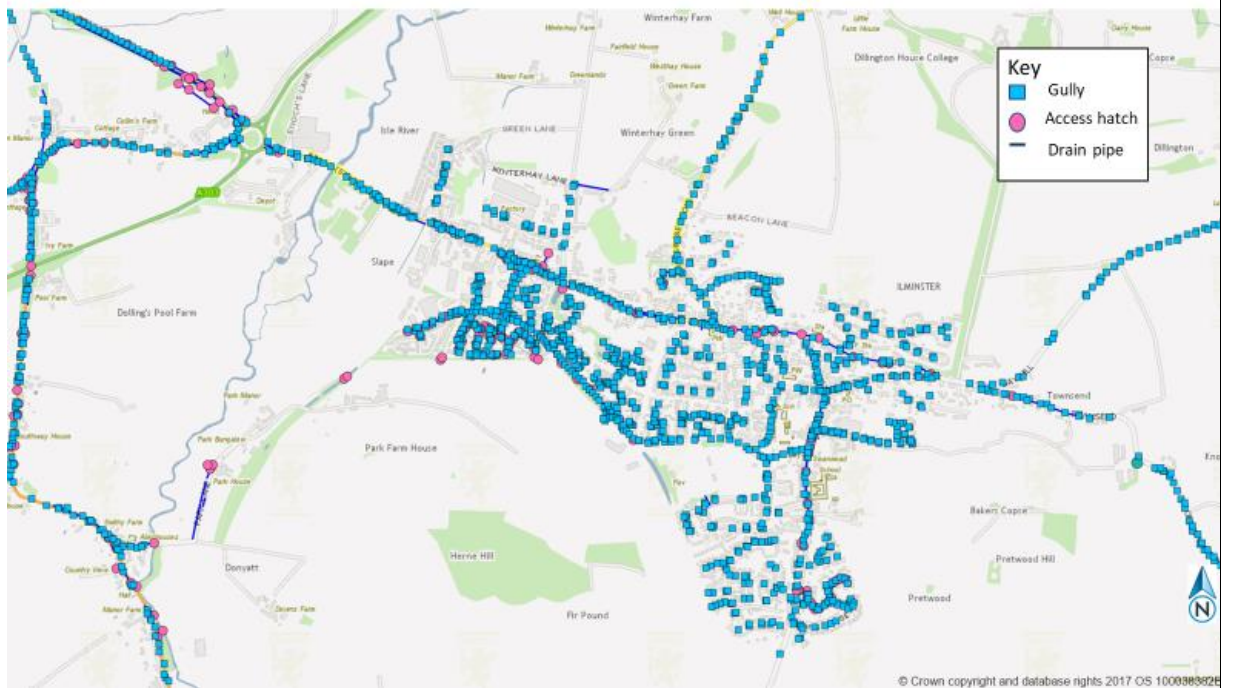
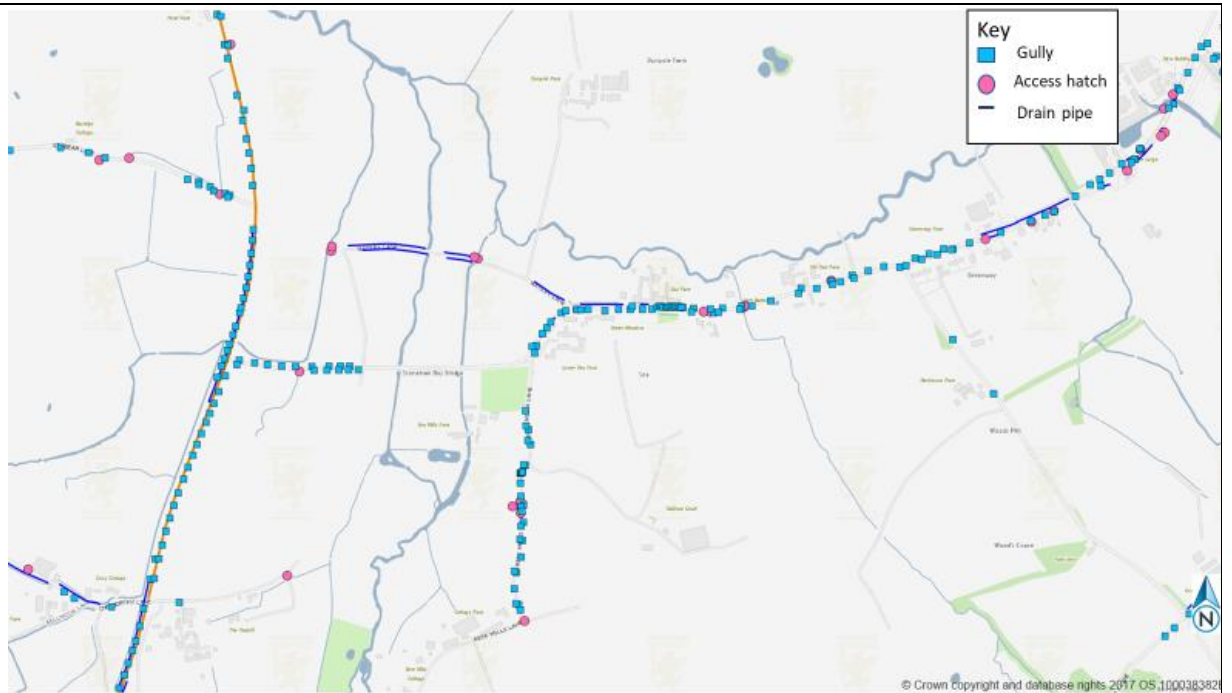
The drainage network around the affected areas is extensive, as the figures show. However, residents and others have noted some significant problems with draining the accumulated rainfall during the incident.

Current design standards for highways drainage require drains to cope with a 1 in 5 year event plus 20% allowance for climate change, and that a 1 in 100 year event not exceed the bounds of the highway. Drainage meeting the current standard would not have coped with the intensity of rainfall during the flood event, and would have overflowed onto the highway or failed to drain all the water away even without any obstruction.

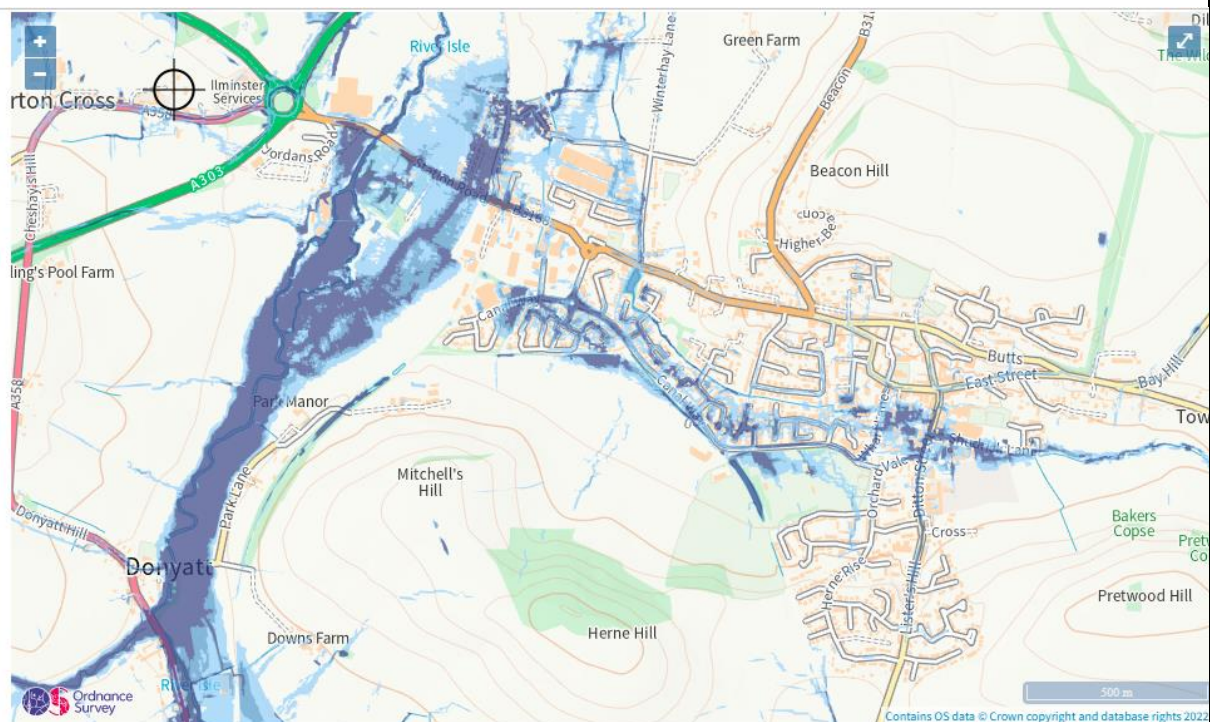
**Figure 23: Surface water flood risk map for the Ilminster**

Maps later in this report will show the estimated flow paths of flood water through Ilminster.

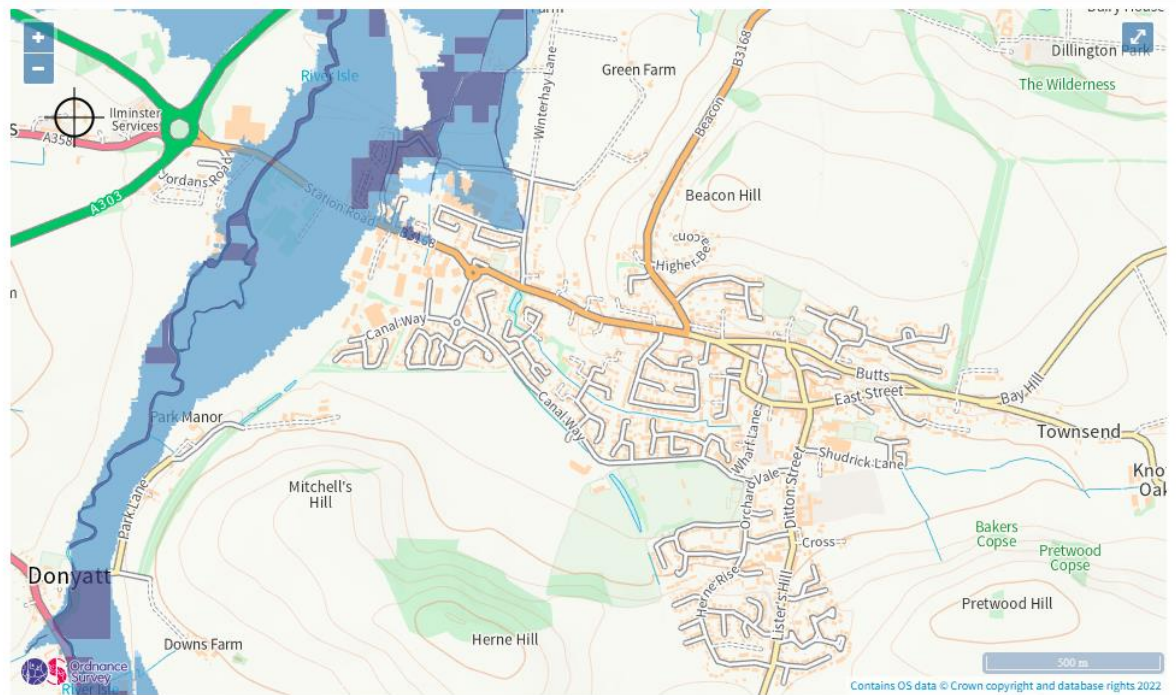
**Figure 25: Fluvial flood risk Ilminster**

The western side of Ilminster was particularly badly affected by fluvial flooding from the River Isle. The river appears to have bypassed the Environment Agency flood defences upstream of the Hort bridge and spread out over the old Dairy Gold site and fields next to the river. It then entered the two park homes sites and surrounding roads, both from the east and from the south, as water ran across station road, as shown in figure 27. It also affected the Rose Mill Industrial estate on the Horton Cross side of the river.
