Somerset County Council

Section 19 Investigation Report

Date of Incident:	20 th October 2021	Date of Report: 22nd September 2022 Version: 3.8 Status: all amendments received to date added – EA and Darren Duffield. Inc new return period.
Site / Catchment Location:	Ilminster

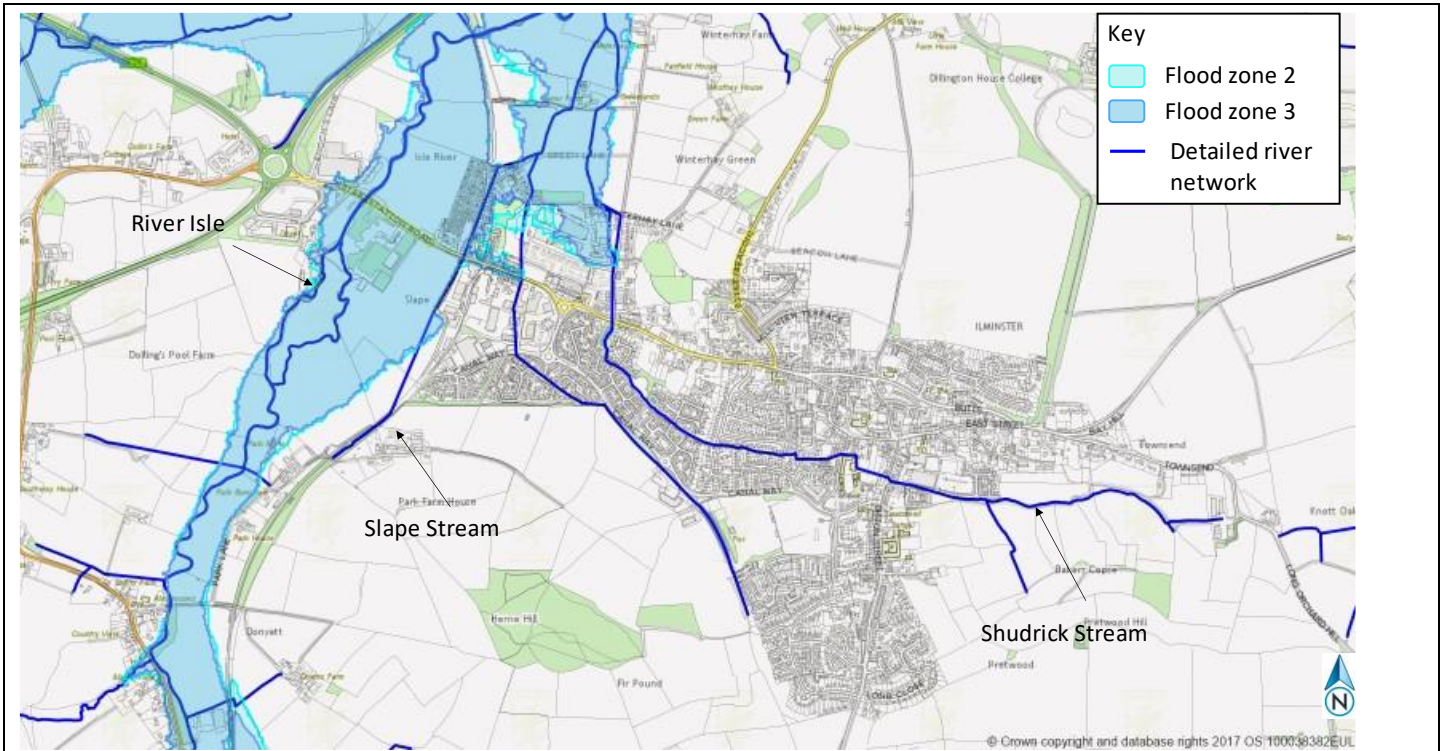
Figures 3 & 4: Flood zones and detailed river network

The above maps also show the risk of fluvial flooding – that is, from the river alone. Flood zone 2 consists of areas that have 0.1-1% chance of flooding from rivers in any year, and Flood zone 3 consists of areas that have a 1% or higher chance of flooding from rivers.

A member of the public has reported that the Figure 3 map above is incorrect, and that the old canal, which runs down the western side of Ilminster town, actually joins with the Shudrick Stream rather than the Snape Stream. This appears to be an issue with the Ordnance Survey map as well as the Environment Agency information from which the above figure derives. The path of this watercourse should be investigated and corrected as necessary.

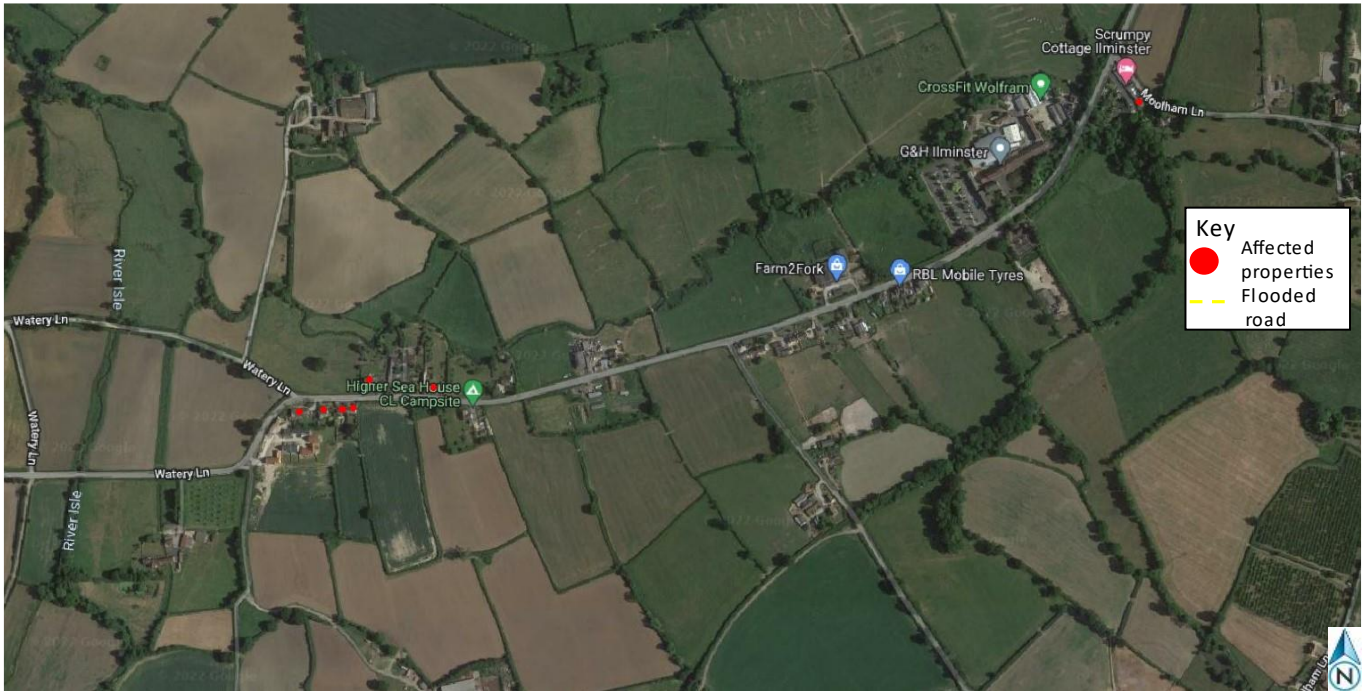
Figure 7: Areas affected in Sea and Dowlish Ford

Six Properties were reported as being affected by flooding in Sea, and one in Dowlish Ford.

In Sea, surface water ran down the main road and entered properties mostly via the front doors. Six properties were flooded internally, some to over 1/2m in depth. One property had a flood door fitted, which failed. Residents said they believed that road drains were blocked. There is also concern that a pond along Watery Lane is adding to the risk by not being properly maintained or managed, and that a ditch near the corner in the road is overgrown.

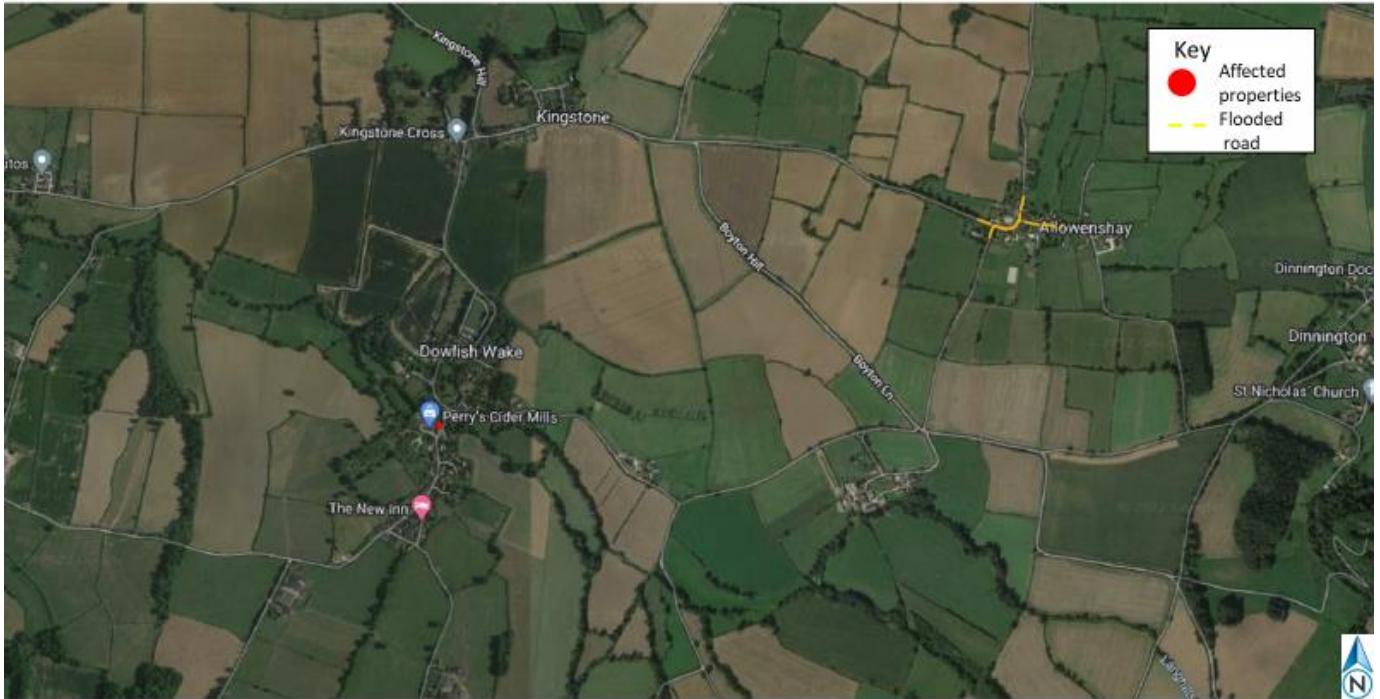
Figure 8: Areas affected in Allowenshay and Dowlish Wake

One property was reported as being affected in Dowlish Wake. Roads were flooded in Allowenshay. Horton Village was also reported as being badly affected, but no details have been received. These are the main areas reported as being affected by flooding in October 2021. Flooded farmland or forestry is not shown.

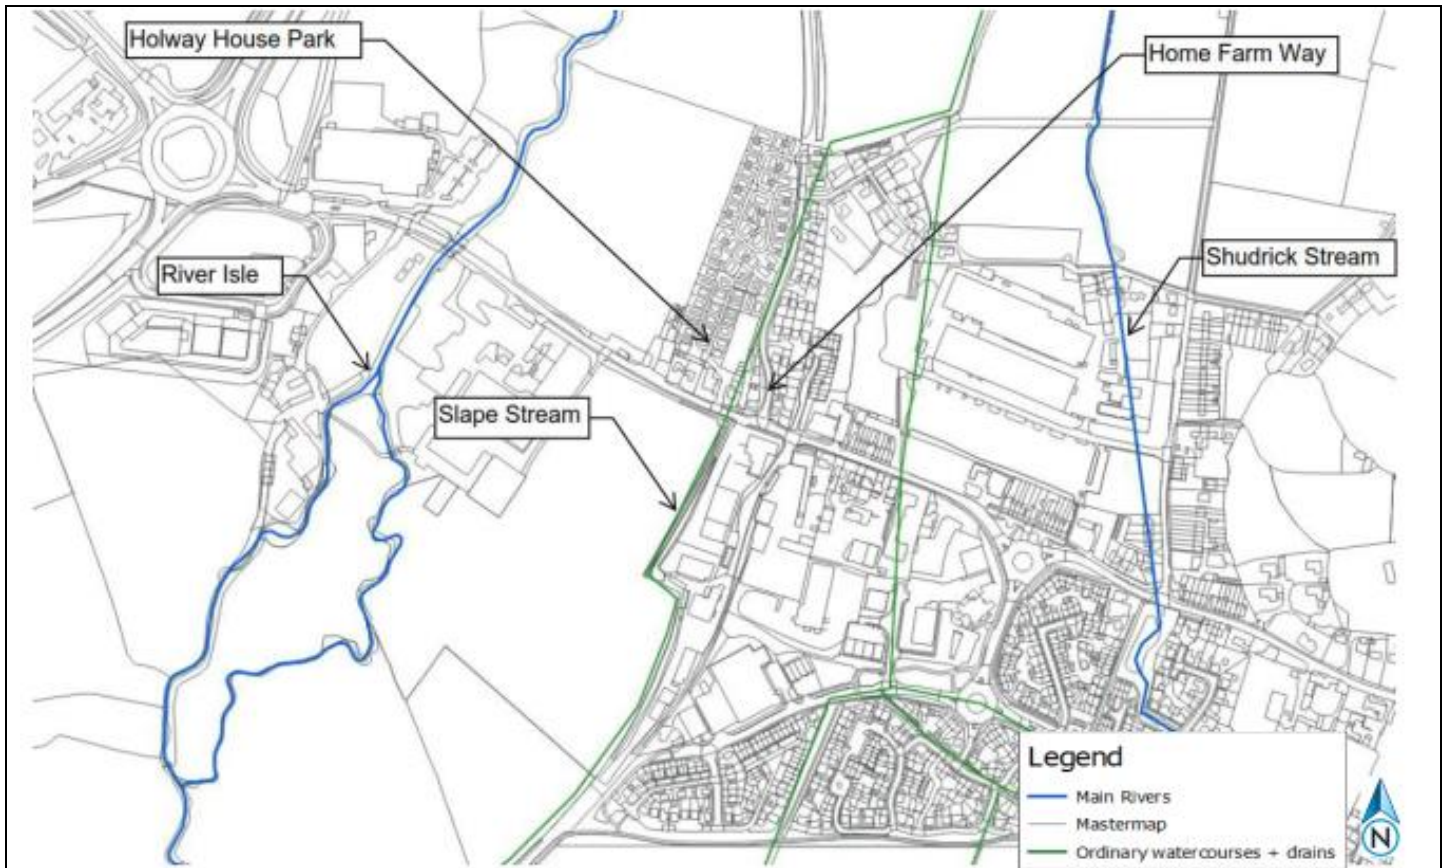
Figure 9: Watercourses around the Park Home sites

The two Park Home sites were particularly badly affected. Houses in Station Road, Green Way and Home Farm Way, and the Rose Mill Industrial Estate also experienced flooding.

Although the Slape Stream is marked on this map as running down Home Farm Way, alongside the residential parks, there is no sign of it on the ground until you get across Station Road, where it appears as a ditch running alongside the small industrial area on the old station site. It is not known whether this is a winterbourne, only appearing during periods of high rainfall, or whether the stream has been culverted under the park homes developments, and re-appears at the surface during high rainfall. The true situation may be a combination of the two.

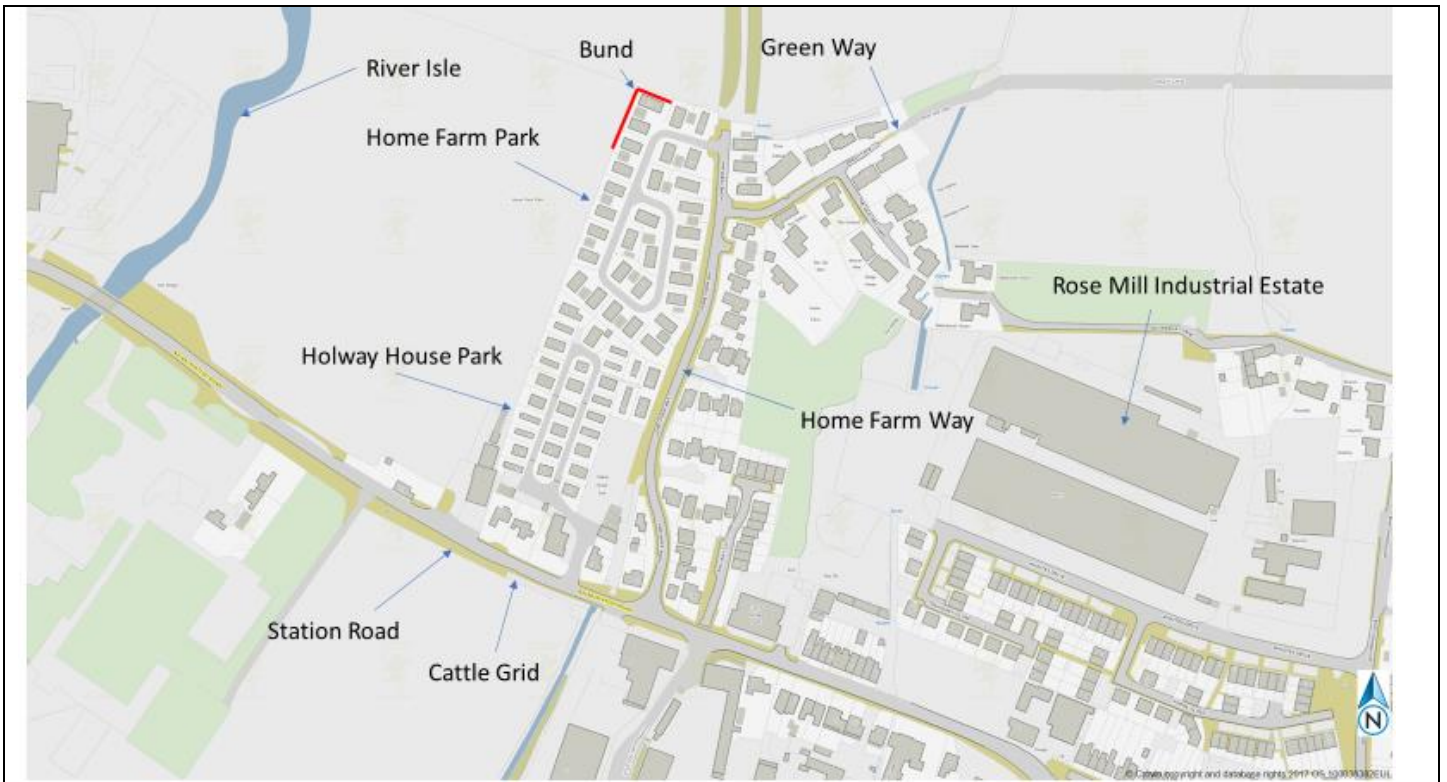
Figure 10: Detail of Park Home sites

The history and placement of the bund shown in Figure 10 will be discussed in a later chapter.

A resident has reported that “When viewed in person from the field to the North of the Park homes it’s clear to see how the Park home gardens have increased slightly in size over many years flattening the Bund, filling the adjoining ditch and removing any usefulness of the original built bund.”. This should be looked at in concert with further work on the ownership and condition of the bund.

Further work needs to be done on the ownership of, and responsibility for, the bund around the Park Homes. The condition of the bund needs to be examined and improved or repaired as required.
