# Flood Investigation Report

*Section 19 Flood and Water  
Management Act 2010*

**Ilminster**

<b>Date of Incident:</b>	20 <sup>th</sup> October 2021	<b>Date of Report: 27<sup>th</sup> January 2023</b> <b>Version: 5.0</b> <b>Status: Final</b>
<b>Site / Catchment Location:</b>	Ilminster

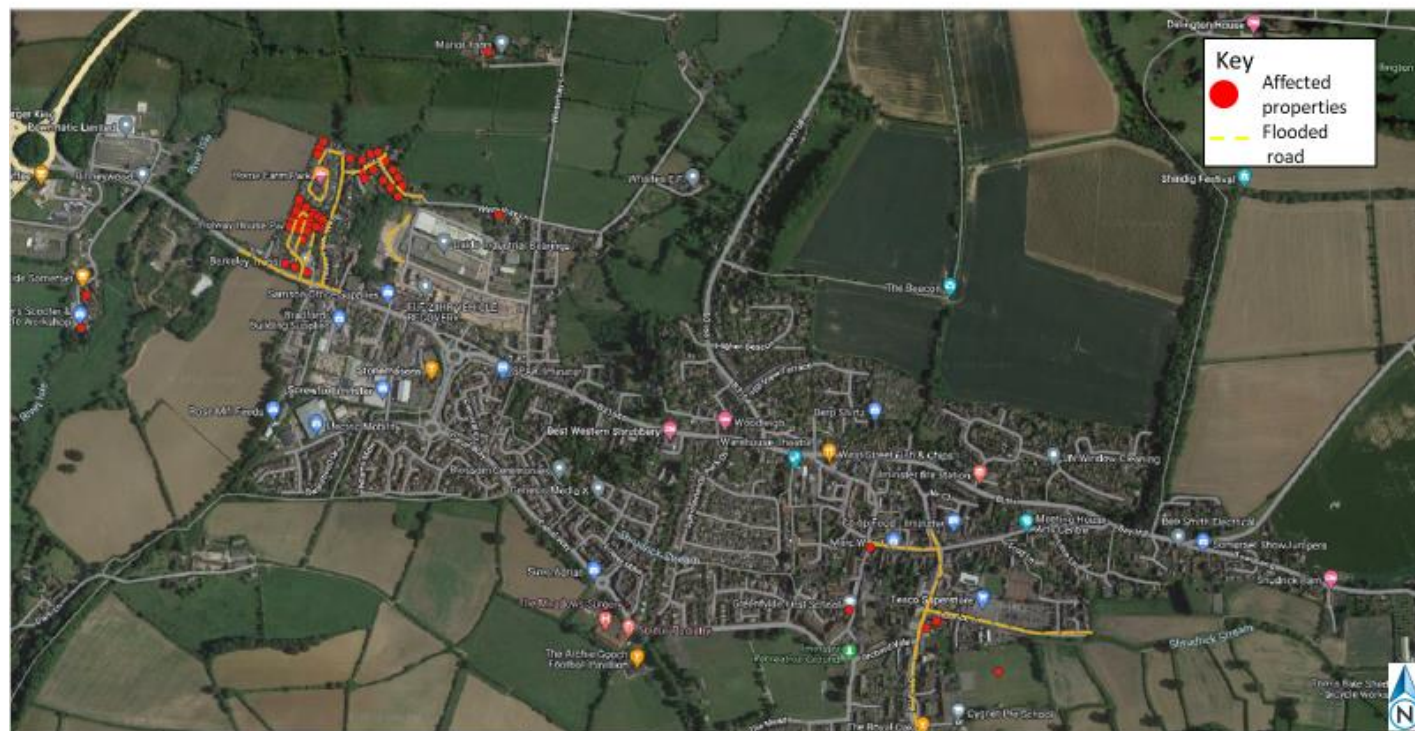
**Figure 6: Areas affected in Iminster**

50 properties have been reported as flooding in Iminster during the event. The actual number affected may be higher, as those affected sometimes do not report having been flooded.

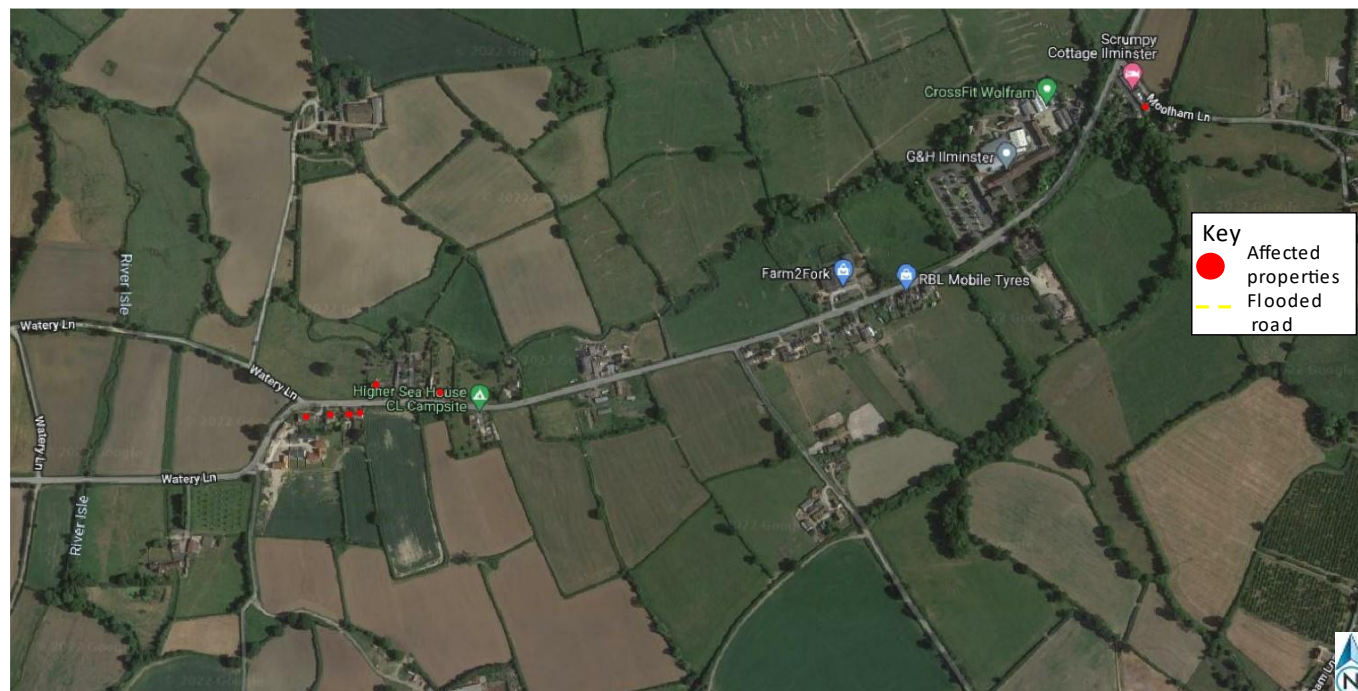
**Figure 7: Areas affected in Sea and Dowlish Ford**

Six Properties were reported as being affected by flooding in Sea, and one in Dowlish Ford.

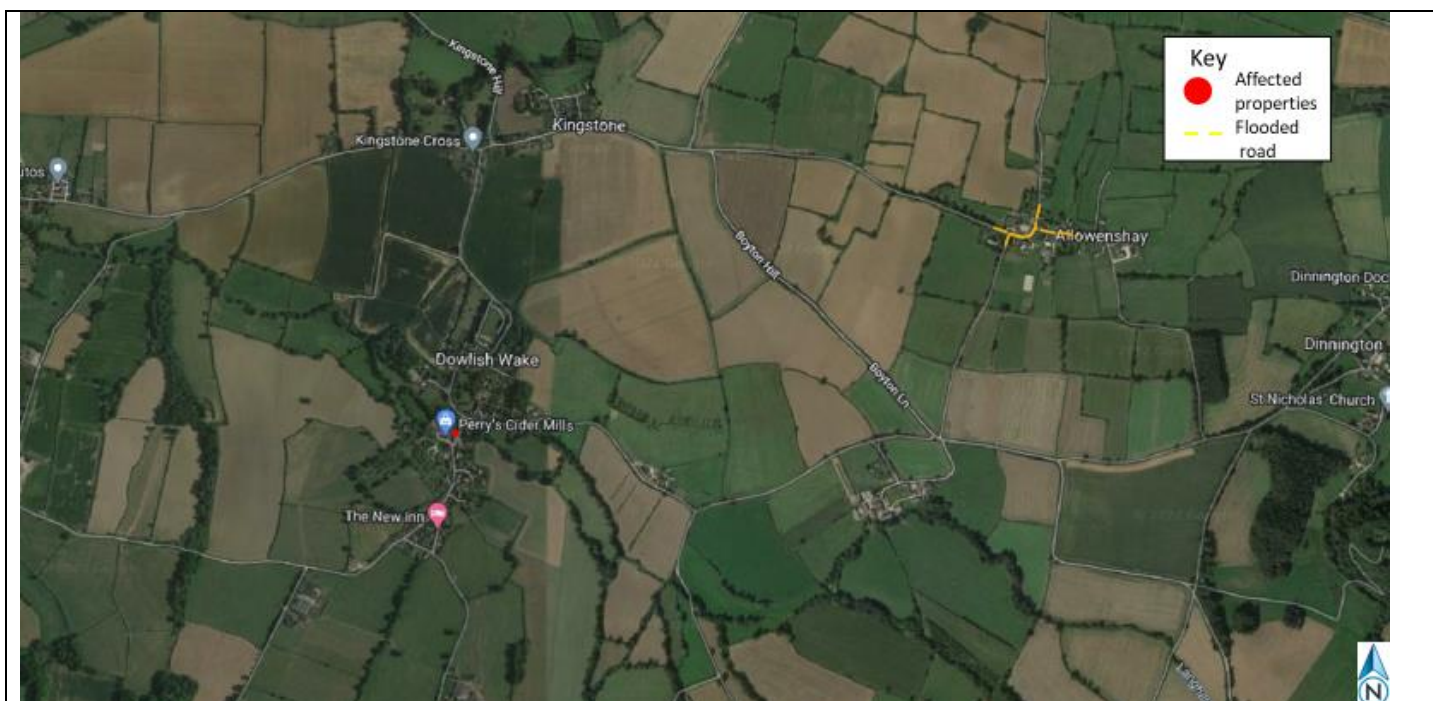
**Figure 8: Areas affected in Allowenshay and Dowlish Wake**

One property was reported as being affected in Dowlish Wake. Roads were flooded in Allowenshay.

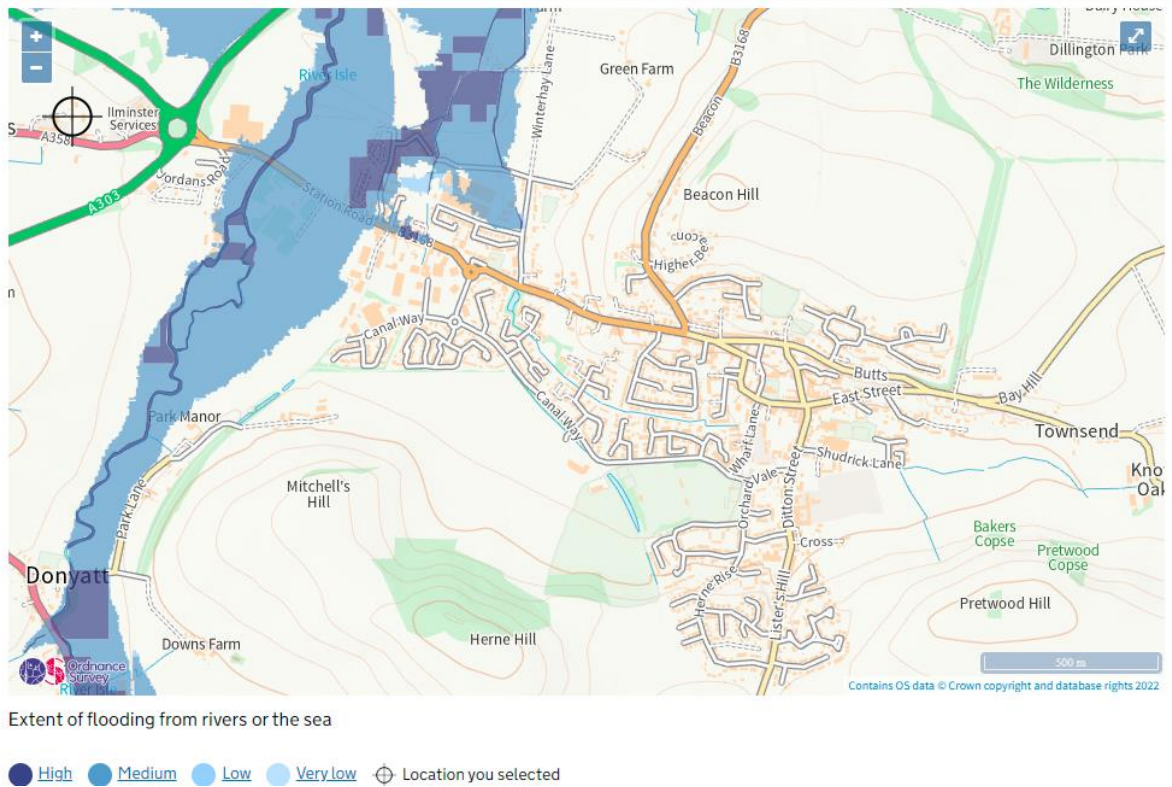
**Figure 27: Fluvial flood risk Ilminster**

The western side of Ilminster was particularly badly affected by fluvial flooding from the River Isle. The river appears to have bypassed the Environment Agency flood defences upstream of the Hort bridge and spread out over the old Dairygold site and fields next to the river. It then entered the two park homes sites and surrounding roads, both from the east and from the south, as water ran across Station Road, as shown in figure 27. It also affected the Rose Mill Industrial estate on the Horton Cross side of the river.
